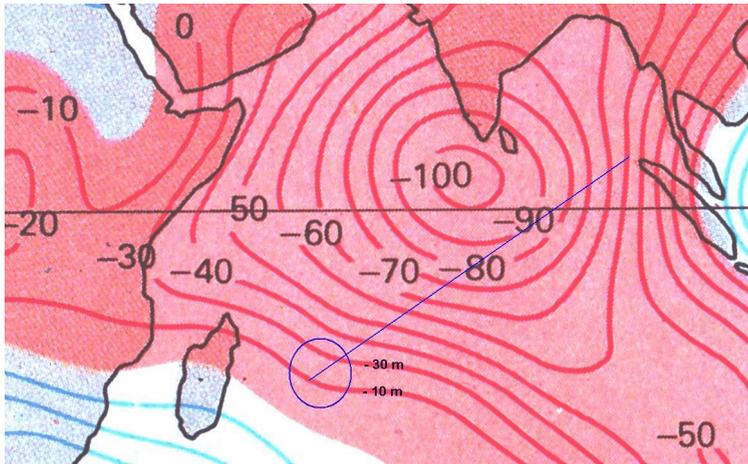
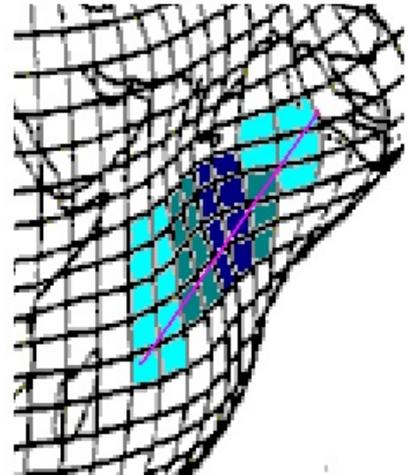
In that particular area, looking from the island towards NE, the earth is not evenly shaped, but has a considerable inward dent. The difference between the island and a location to the SW of Sri Lanka is about 90 metres, which is the max. indent in that part of the globe.

For an a/c approaching the island from the NE, the significant 'drop' of the horizon would be about 20 metres. In other words, to a given ground station antenna height, about 20 metres can be added. As a consequence of this, an a/c in that area may actually be lower than calculated by standard formulae, and still be in line-of-sight with a station on MRU.

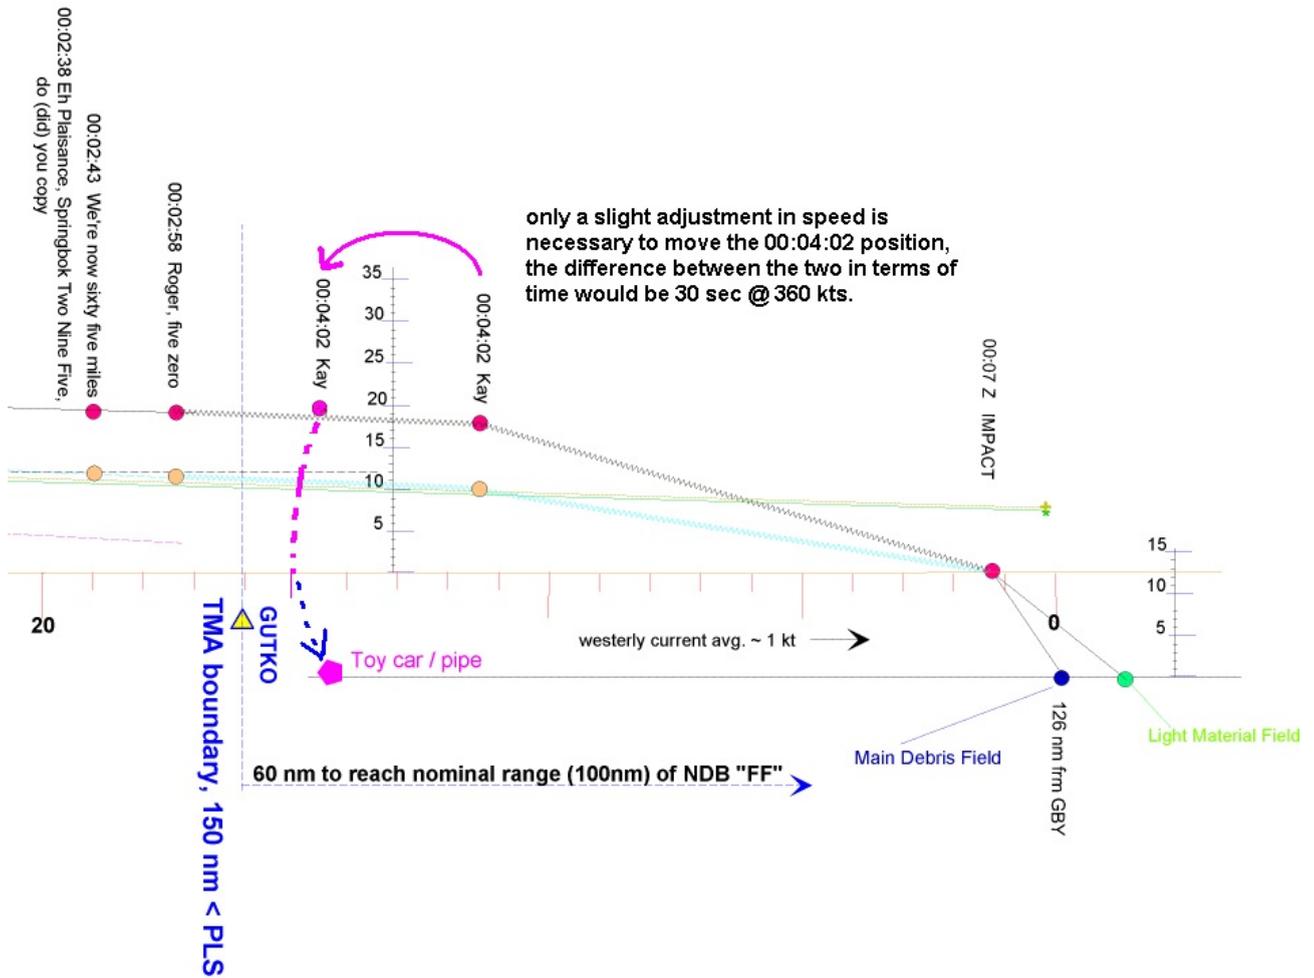
After reading through reports covering TWA800, PA103, AI182, UA811, where it is argued that, the starboard forward lower cargo door opened in flight, I am becoming more and more convinced that, this happened here also. The locking mechanism activated either by faulty wiring plus water; it was raining, foggy at CKS, tarpaulin over pallet; certainly a high relative humidity, which later dripped as condensate on wires into the bilge; or the electrical system, damaged by the fire going wild for a few seconds before going dead.

"We have lost all electrics...", although there must have been some power available until 00:04:02 Z (Kay), and at that time the door could have burst open.

The consequence of such an explosive decompression would be:  
 the cargo door or parts of it detach, followed by parts of a cargo pallet or cargo, and damage engine No.3, loss of power on the starboard side;  
 possible damage to the leading edge of wing, loss of lift on the starboard side,  
 a/c turning and roll to starboard, right wing down, pipe(s) from engine No.3 ripped off,  
 rupture of fuel pipes, hydraulic pipes, loss of fuel, hydraulic fluid.

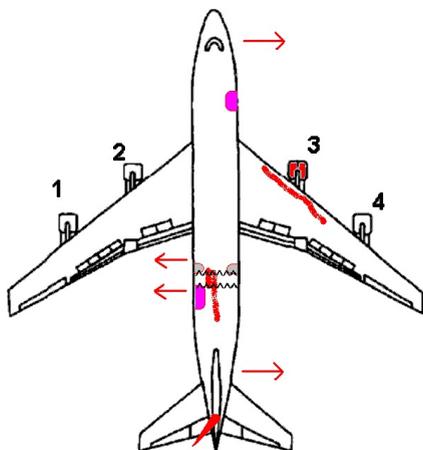
Assuming he was flying manually, an almost instinctive counter action, rudder (full) left, would put considerable additional stress on the hull, structurally weakened by doors 4 L & R, plus the cargo door just aft of door 4 L. Add to that any material fatigue caused by the fire, and additional stress due to the shock wave(s) caused by an explosive decompression, plus turning, rolling a/c, then a break-up looks inevitable.

The average speed from that point (00:04:02 Z) until impact about 14 nm further on would be about 270 kts.

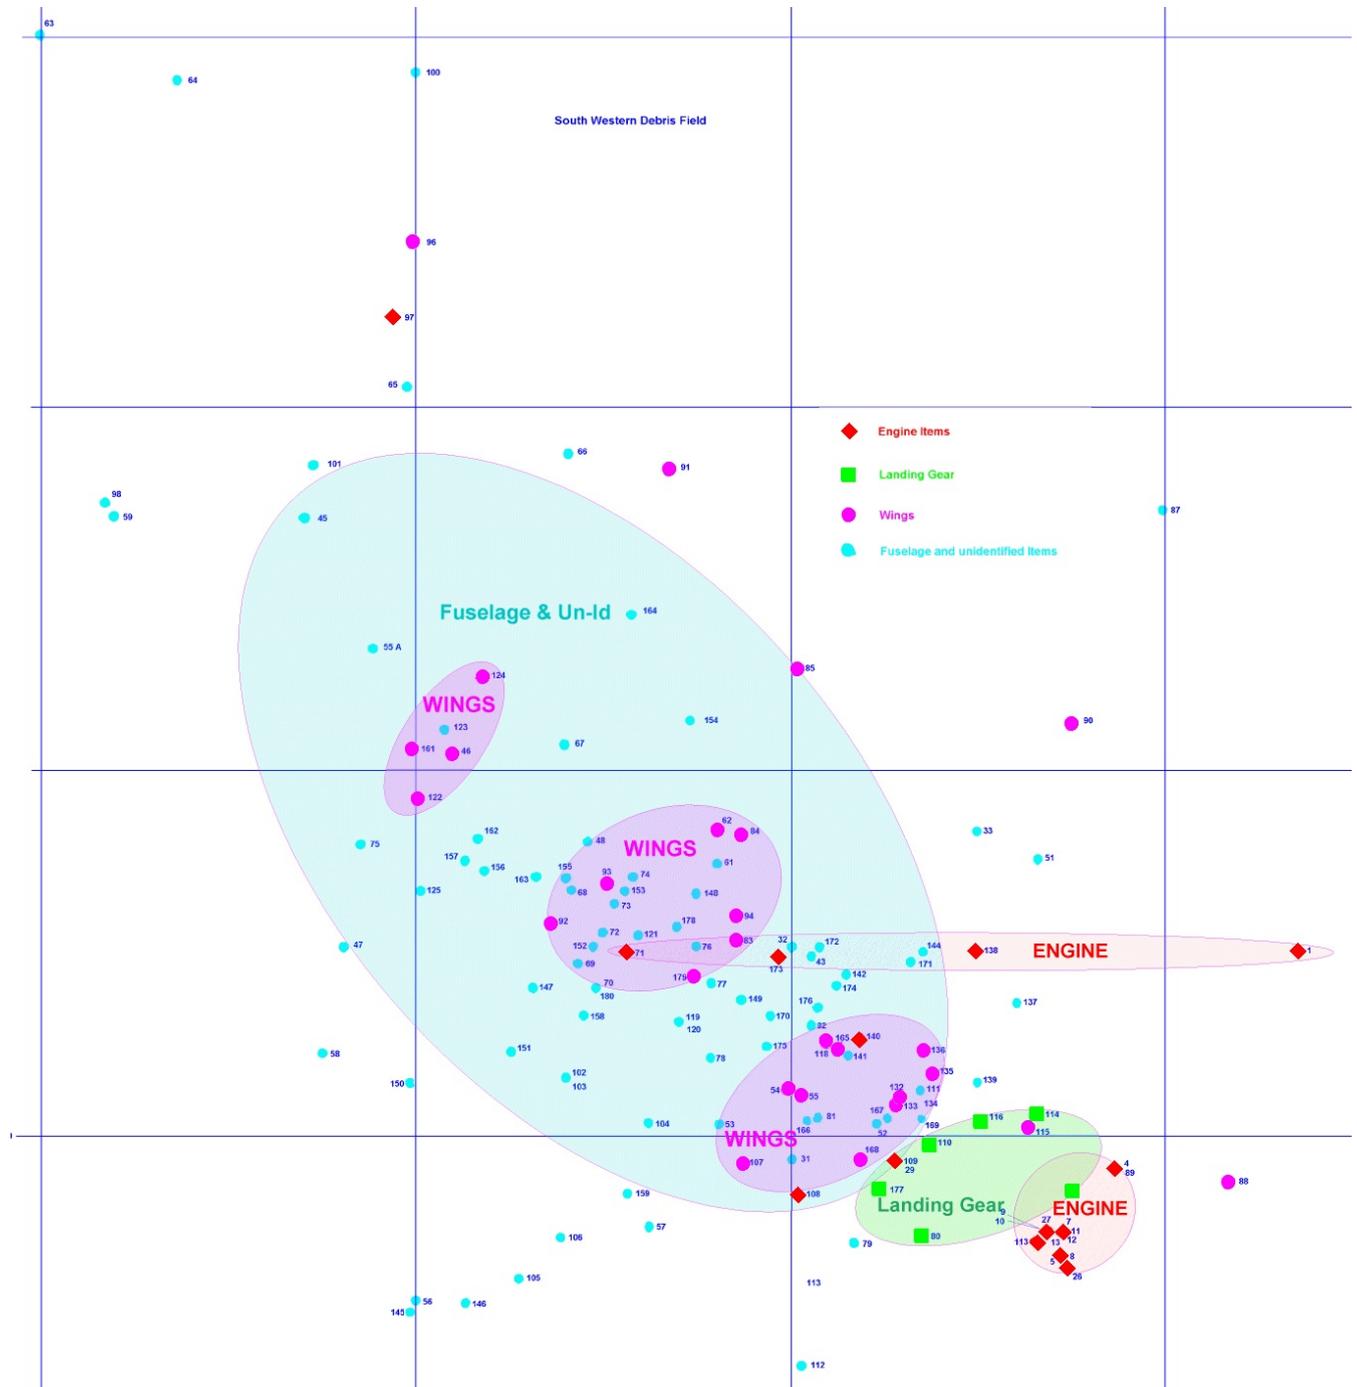
## SW Debris Field

Looking over the diagrams of the debris fields, I found it rather difficult to make something out of it, due to the small size. Only the SW field diagram could be manipulated in such a way as to become 'readable'. A worked-over version is attached. Do you have any idea where the CVR was found? Is this location marked anywhere on the diagrams?

Considering the distribution of debris, it appears plausible that, 1. the plane broke in half shortly before impact, 2. the impact of at least the forward part, (from door 4 forward) happened sideways, starboard side first. Engine and landing gear almost one on top of the other (SW debris field).
