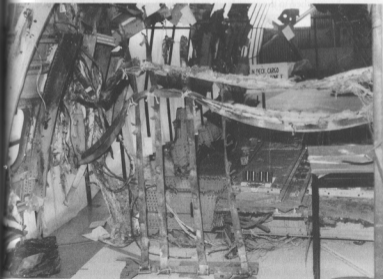
*RIGHT: Right-hand forward main cargo compartment fuselage structure with remains of the 9-G net attached. The fire originated in this section of the cargo compartment before it spread rearwards.*
