**AIRCRAFT
ACCIDENT
REPORT
Pan Am Flight 103
Part I
Consideration of Reasonable Probable Causes**

**Report on the accident to
Boeing 747-121, N739PA
at Lockerbie, Dumfriesshire, Scotland
on 21 December 1988
by John Barry Smith,
Independent Aircraft Accident Investigator**

Part I: Consideration of Reasonable Probable Causes

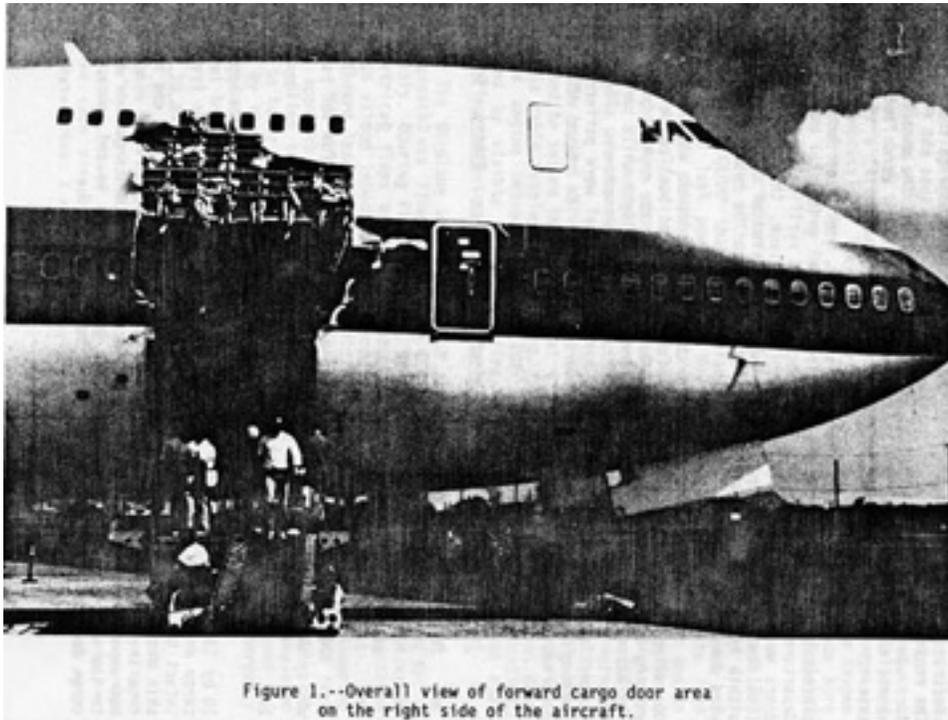
Figure 1.--Overall view of forward cargo door area on the right side of the aircraft.

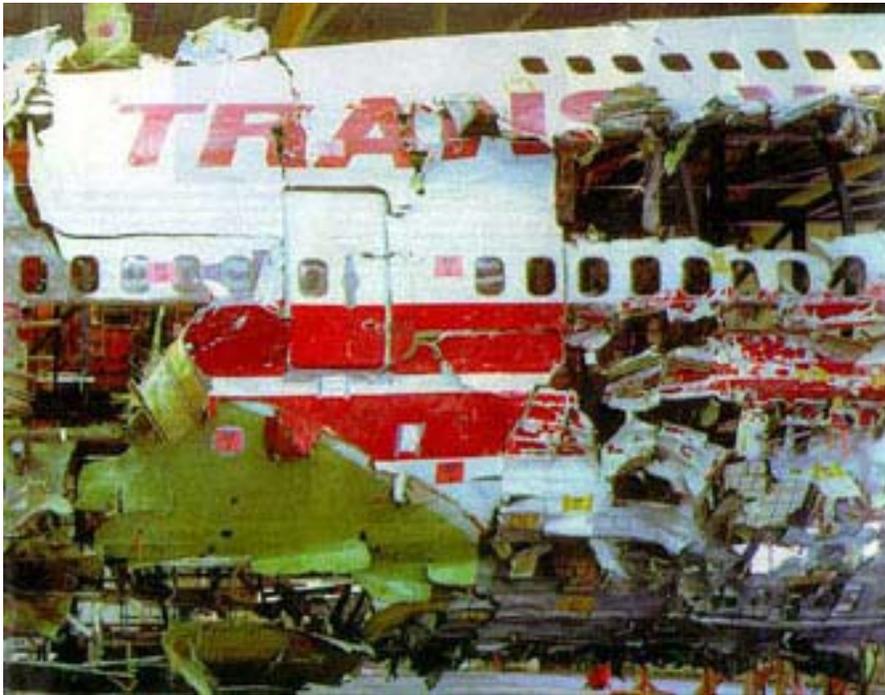
Above/previous page is a NTSB photograph of the wreckage reconstruction of Trans World Airlines Flight 800 starboard side over and forward of the wing. Fuselage station 600 is to the right extending to fuselage station 960 to the left in the photograph. A little over half of the forward cargo door is the shattered area in the lower right hand section. An outward opening petal shaped rupture can be seen at the aft midspan latch of the forward cargo door. The mildly damaged right hand, number two passenger door is in the middle left of the photograph.

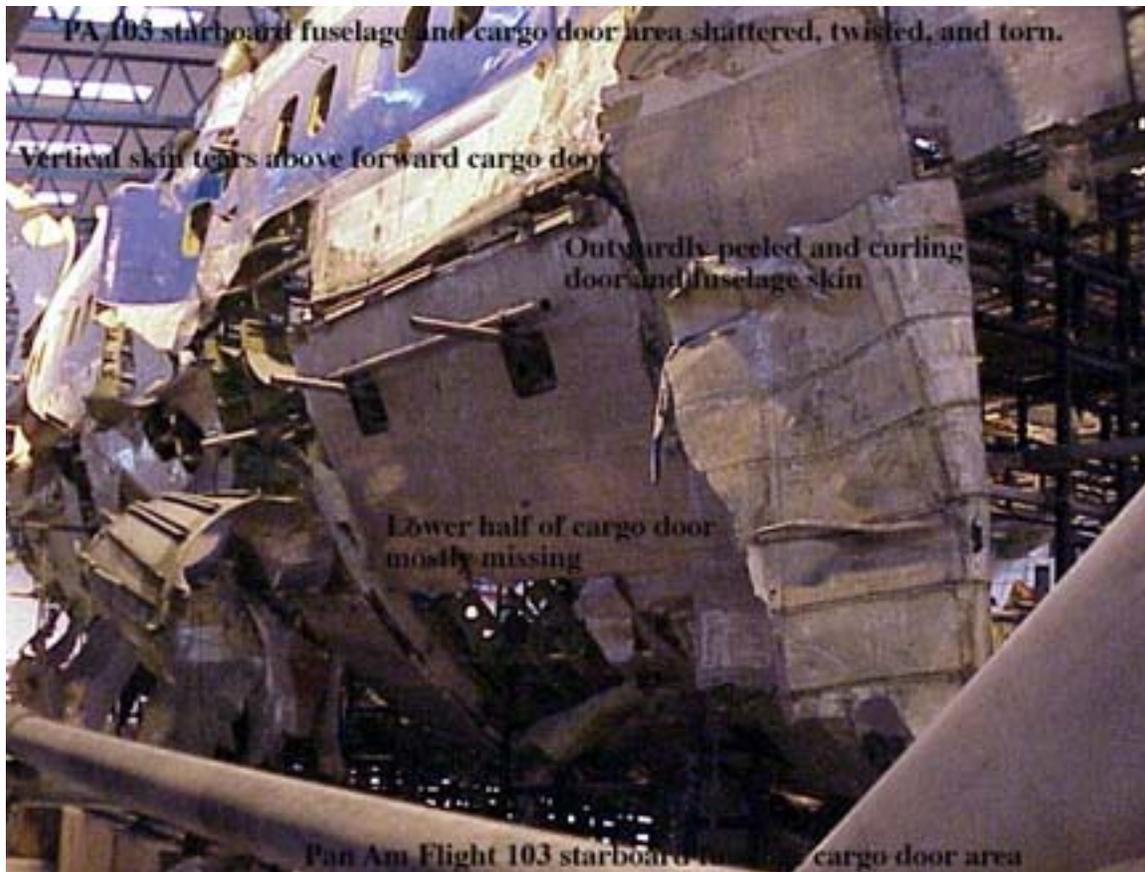
Above AAIB photograph of forward cargo door area of Pan Am Flight 103 shows the peeled back skin, vertical tear lines, and general shattered appearance.

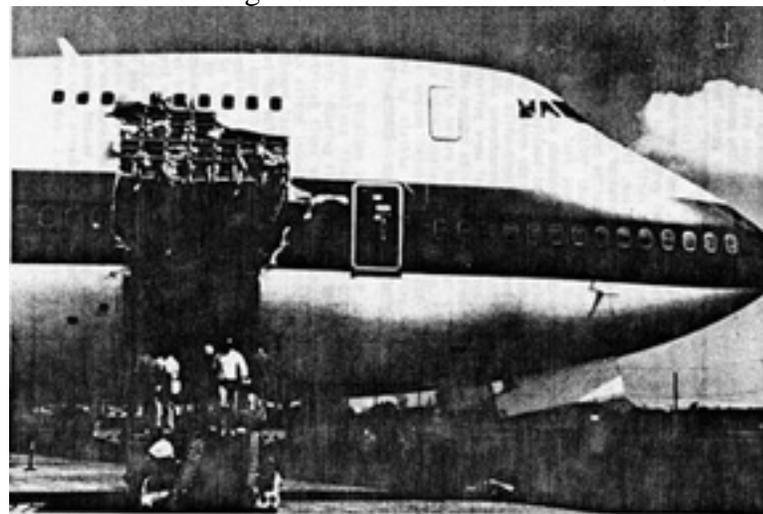
Figure 1.--Overall view of forward cargo door area on the right side of the aircraft.

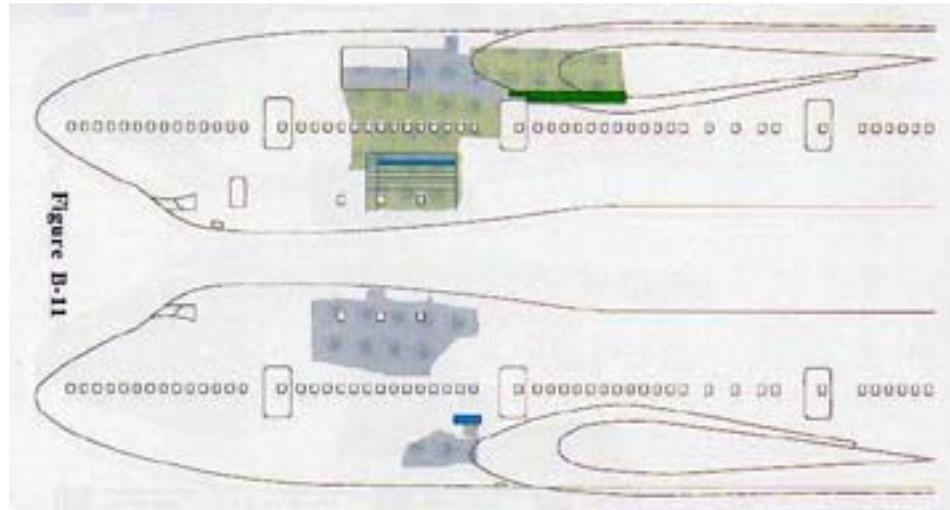
Above drawing from Figure B-11 of the AAIB report shows the large amounts of fuselage skin around the forward cargo door (top drawing) torn away at initial event time while on the port side (bottom drawing) at the same time, only a few pieces are torn off. The dark blue rectangle is the very small 'bomb explosion' shatter zone which is purported to have caused the aircraft to break in two.

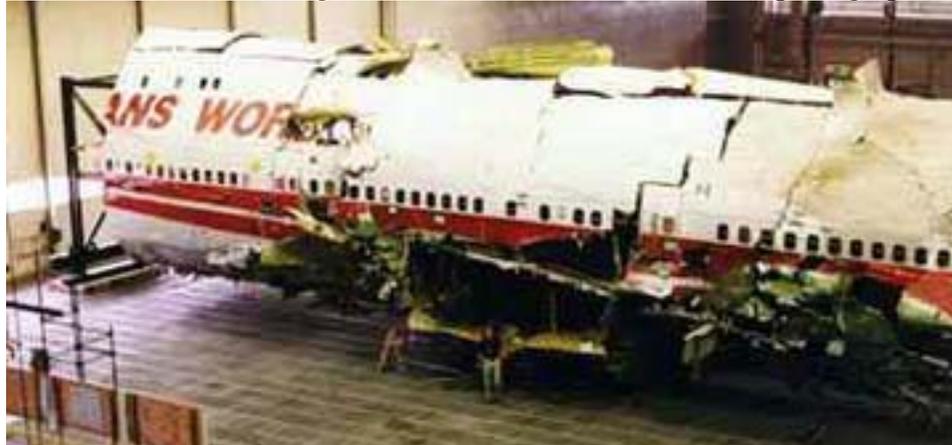
Above photograph shows the smooth port side forward of the wing (nose to left in photograph), while directly opposite the starboard side is shattered and torn. There was no inflight damage to engines Nos. 1 or 2, both on the port side of the aircraft.

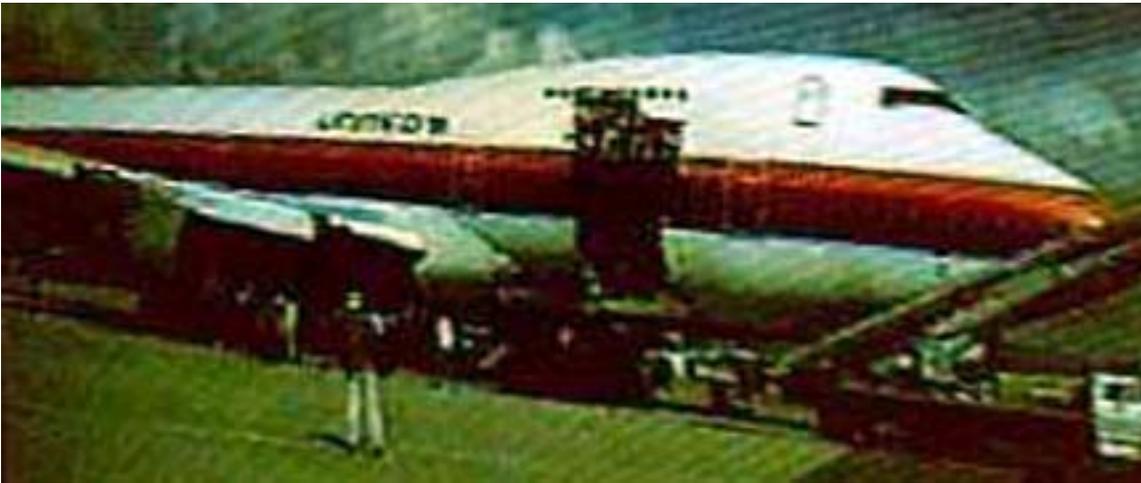
Photo of hole in United Airlines Flight 811 made by inadvertent opening of forward cargo door in flight.

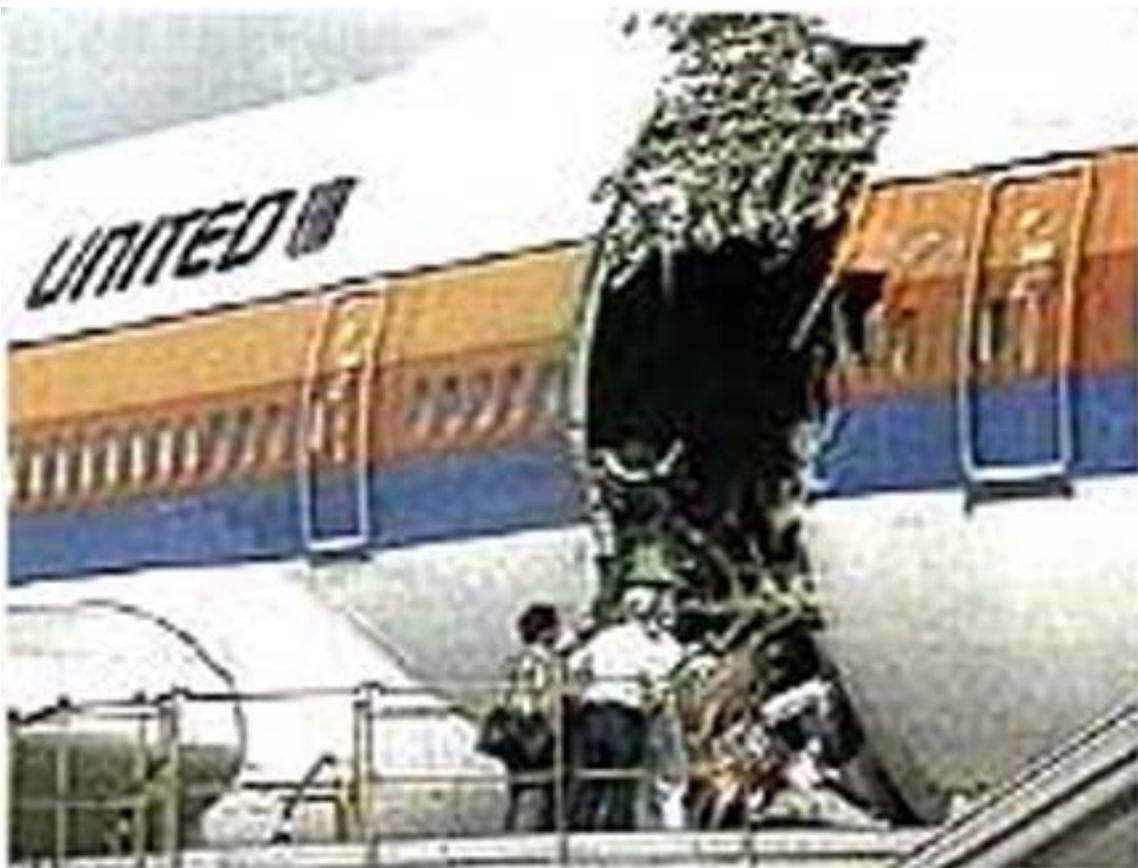
Photo of hole in United Airlines Flight 811 made by inadvertent opening of forward cargo door in flight.

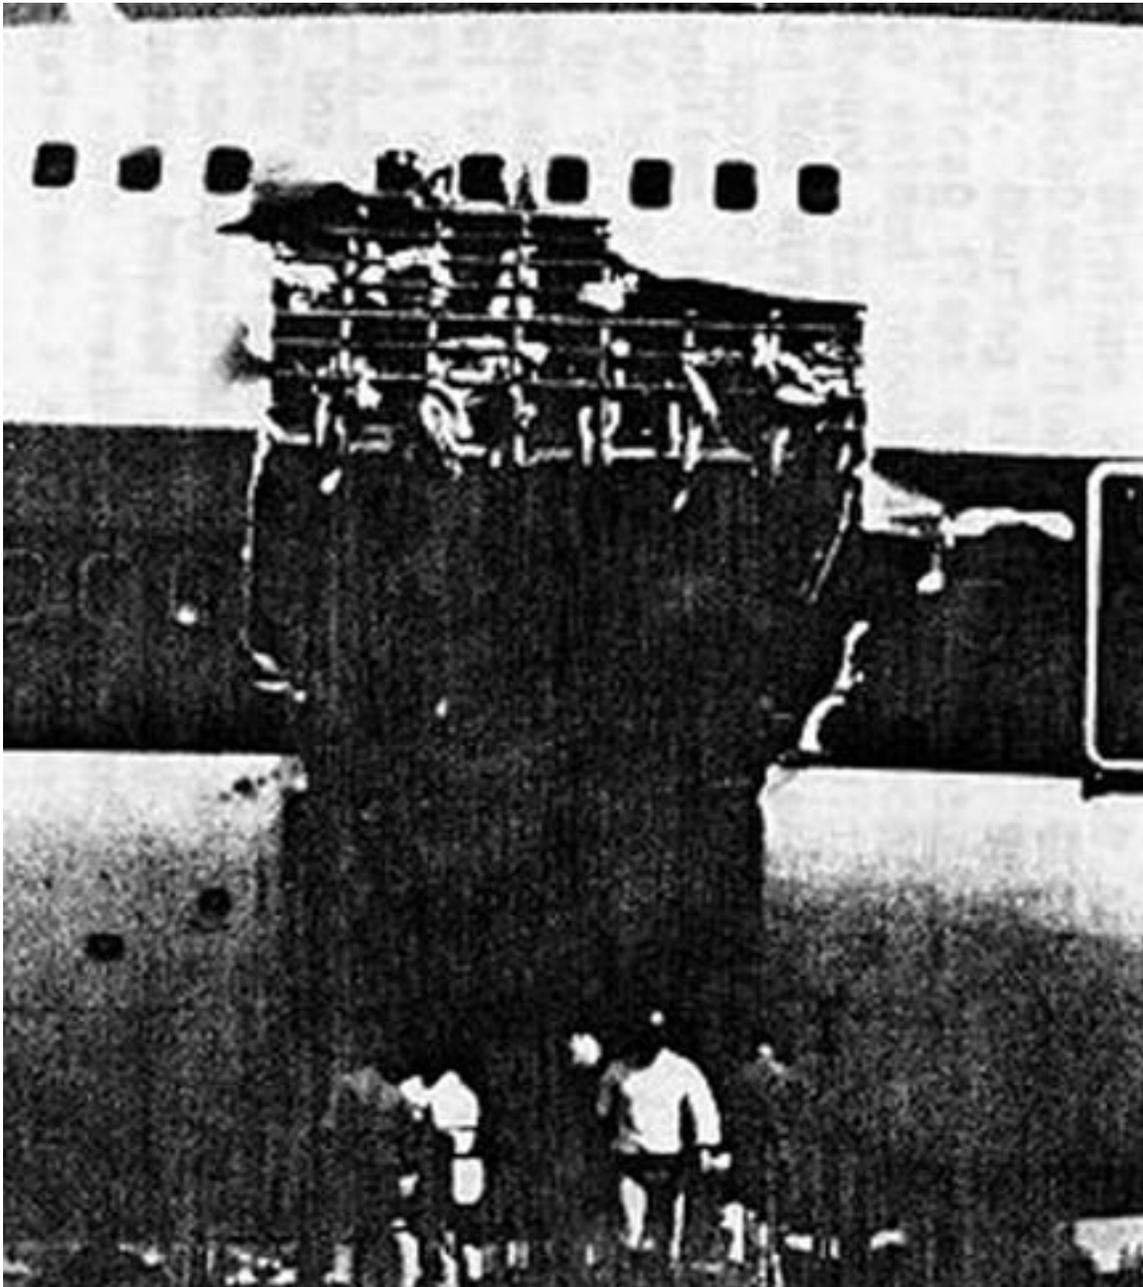
Photo from NTSB AAR 92/02 of hole in United Airlines Flight 811 made by inadvertent opening of forward cargo door in flight.

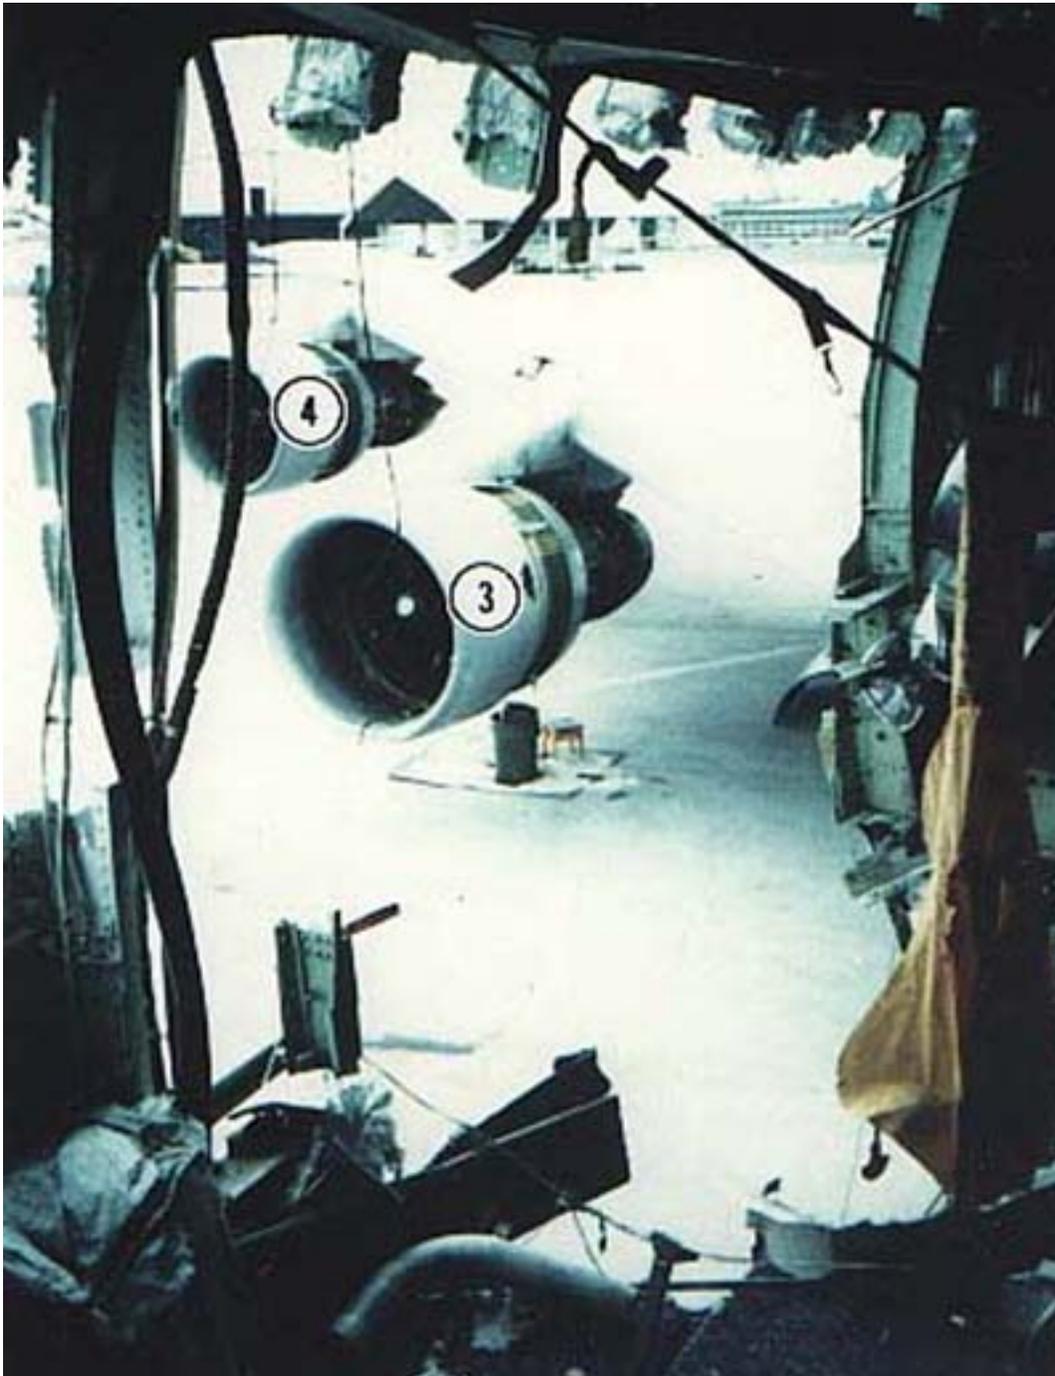
Photo from inside United Airlines Flight 811 showing the hole caused by inadvertent opening of forward cargo door in flight revealing engine numbers three and four which received the ejected foreign objects which caused the fire and internal engine damage.

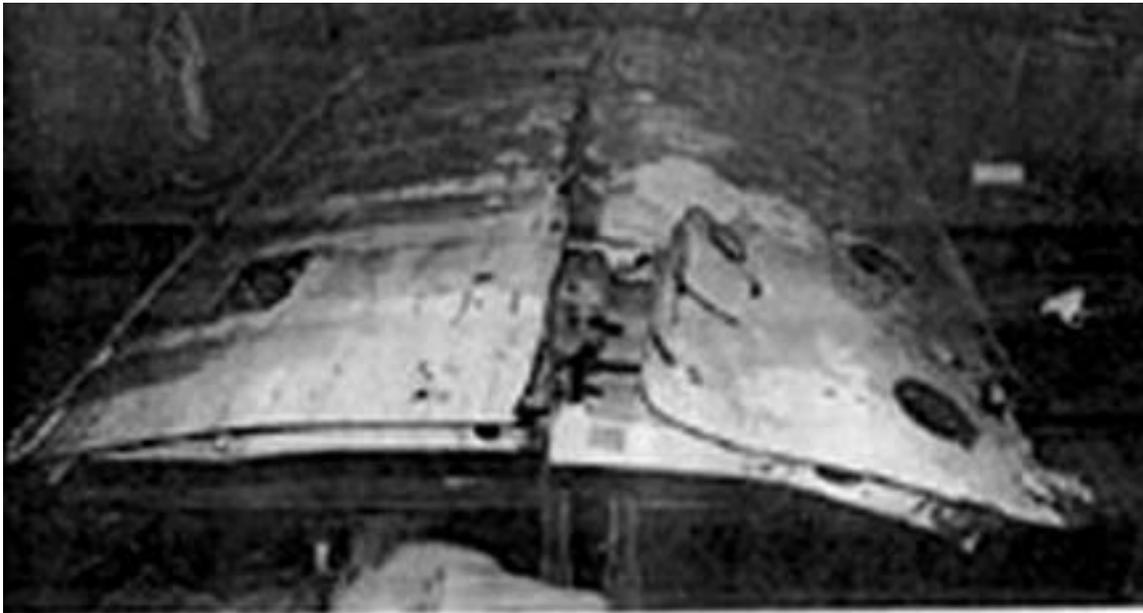
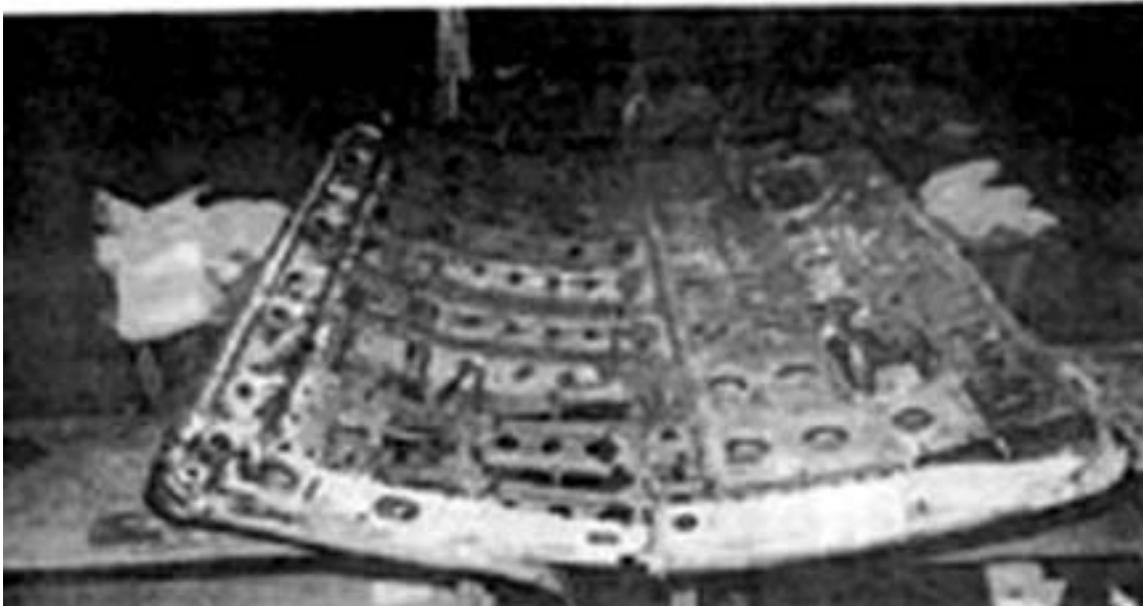
Photo from NTSB AAR 92/02 for United Airlines Flight 811 showing both halves of the retrieved door, the longitudinal split at midspan latches, and the peeled away skin from the aft midspan latch.

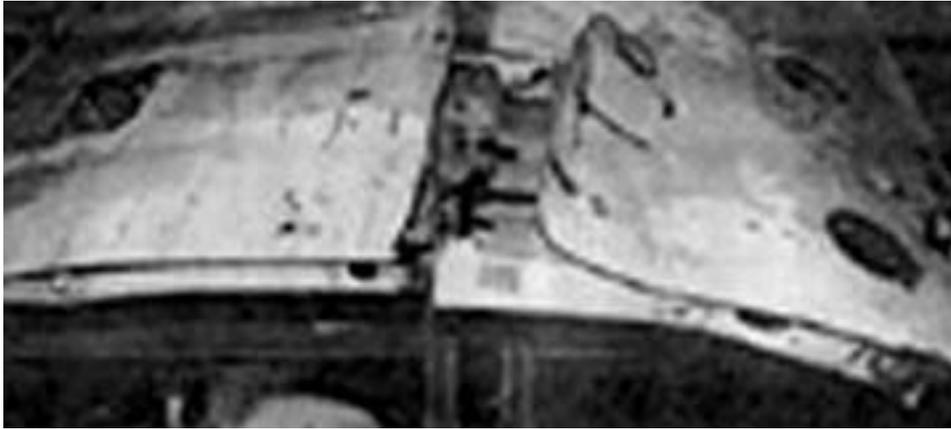
Photo from NTSB AAR 92/02 for United Airlines Flight 811 showing bottom half of the retrieved door, the longitudinal split at midspan latches, and the peeled away skin from the aft midspan latch.

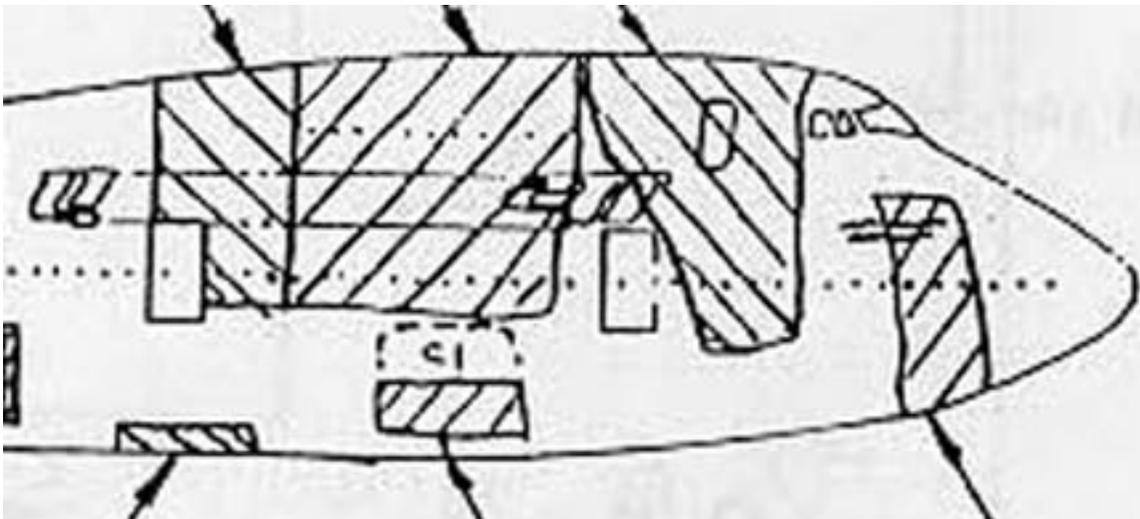
Reconstruction drawing from the Kirpal Report and the CASB report on Air India Flight 182 showing the longitudinal split of the forward cargo door and the vertical tearing of the skin above the door.

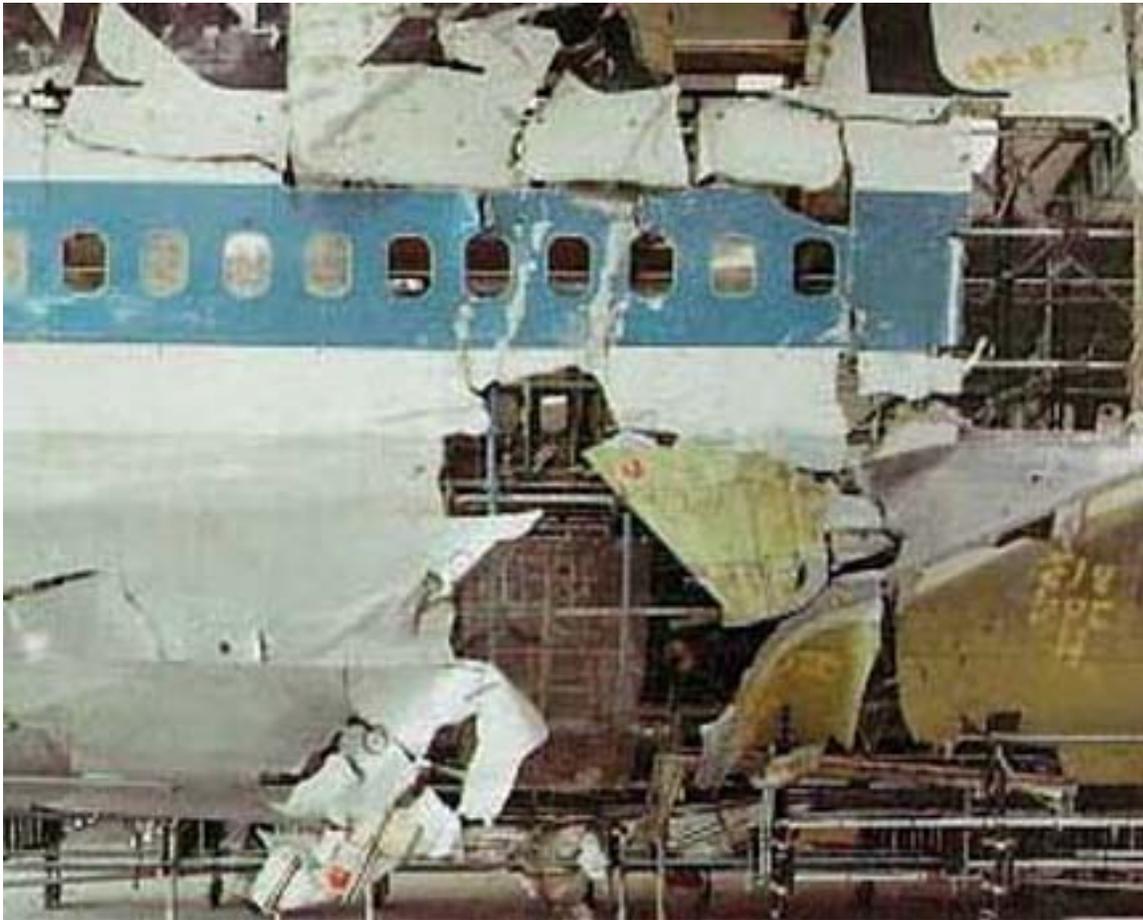
Port side of Pan Am Flight 103 forward of the wing showing the small 'bomb' hole and relatively smooth and intact fuselage skin around it.

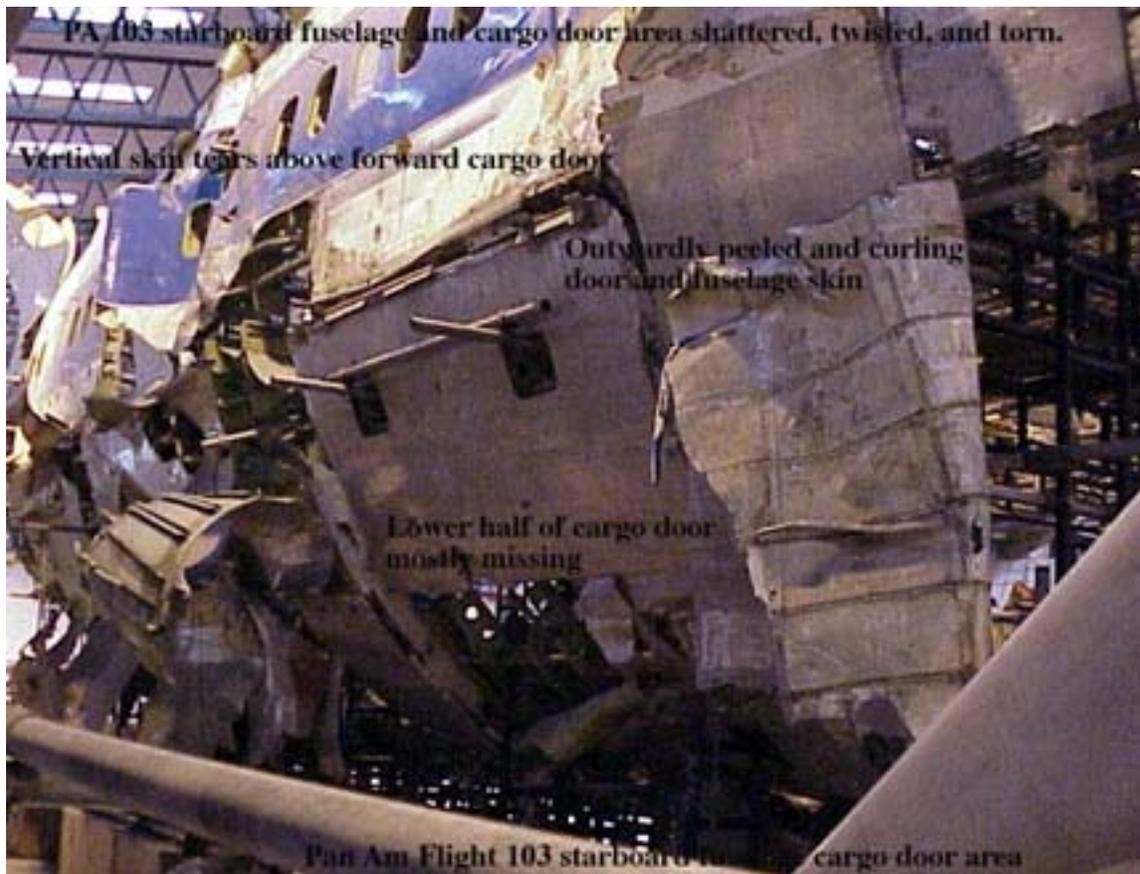
Photograph from AAIB showing Pan Am Flight 103 forward cargo door area revealing the vertical torn skin above door, peeled back and down skin from the aft midspan latch, generally shattered area, and mostly missing lower half of door which includes the manual locking handle and the eight bottom latches.

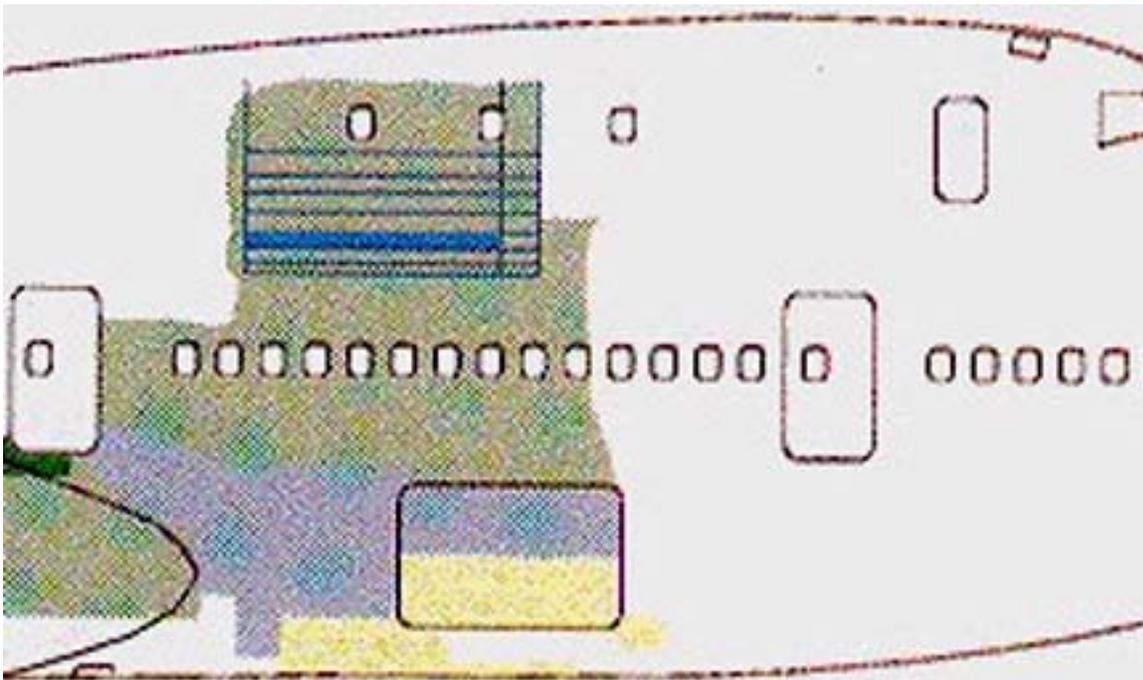
Reconstruction drawing from the AAIB 2/90 report on Pan Am Flight 103 showing the large area of torn off skin around the forward cargo door, the longitudinal split of the door, and the vertical tearing of the skin above the door.

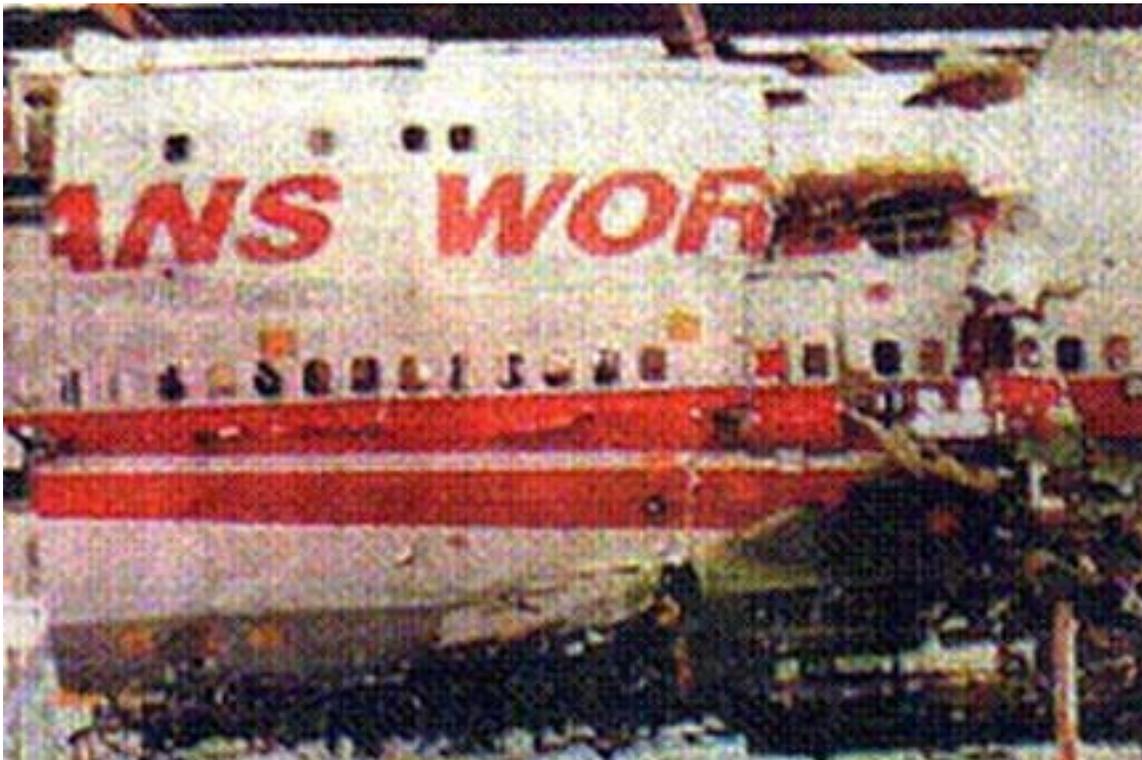
Photograph of the port side of Trans World Airlines Flight 800 showing the relative undamaged skin forward of the wing.

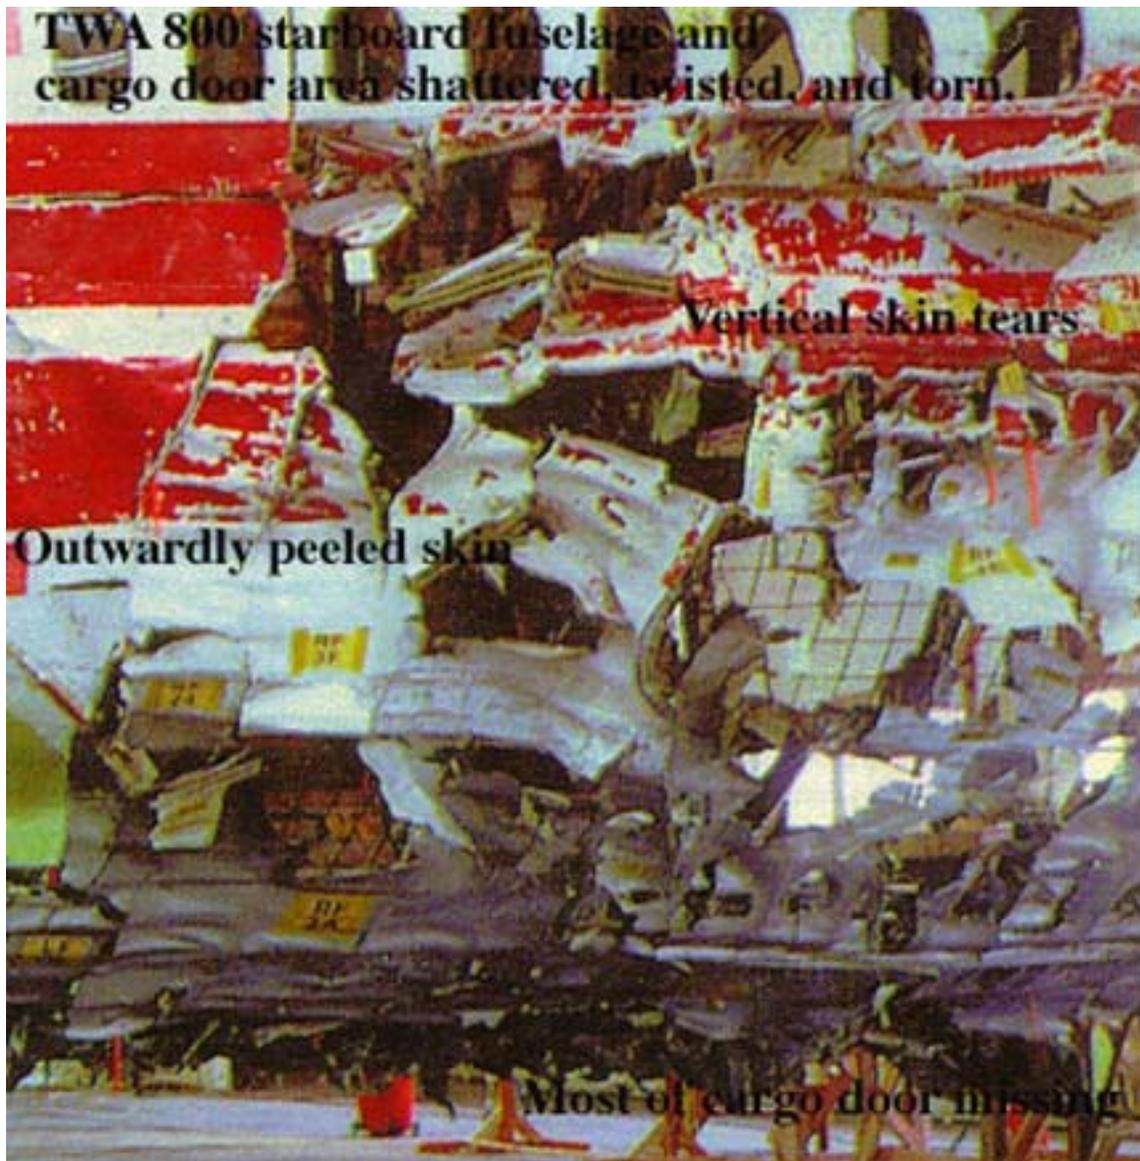
Shattered starboard side around forward cargo door of Trans World Airlines Flight 800 revealing outwardly and petaled shaped skin around aft midspan latch.

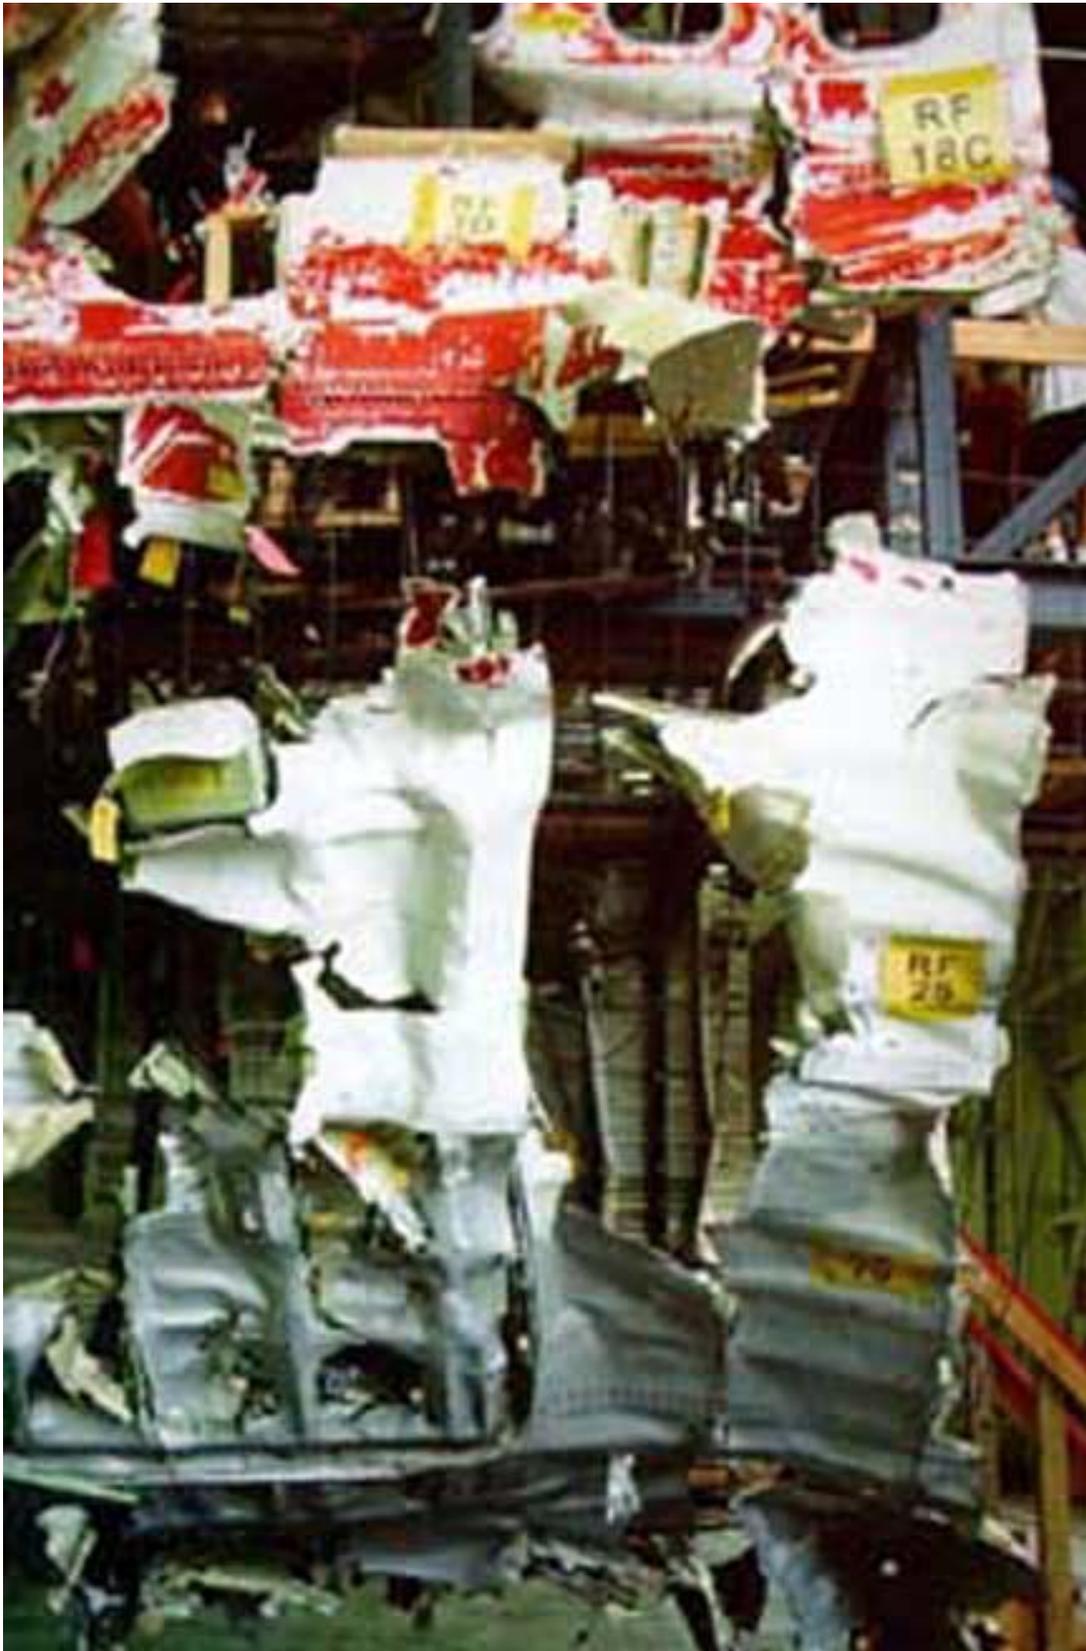
Photograph previous page/above showing outwardly and petaled shaped skin around forward midspan latch.

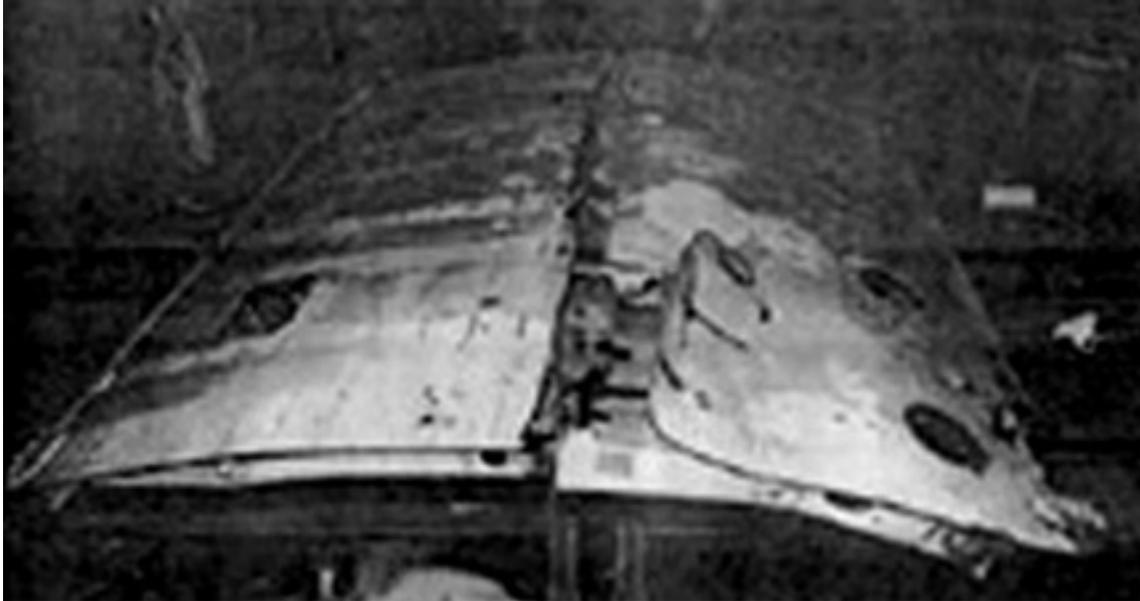
Photos from NTSB AAR 92/02 for United Airlines Flight 811 showing bottom half of the retrieved door, the longitudinal split at midspan latches, and the peeled away and down skin from the aft midspan latch.

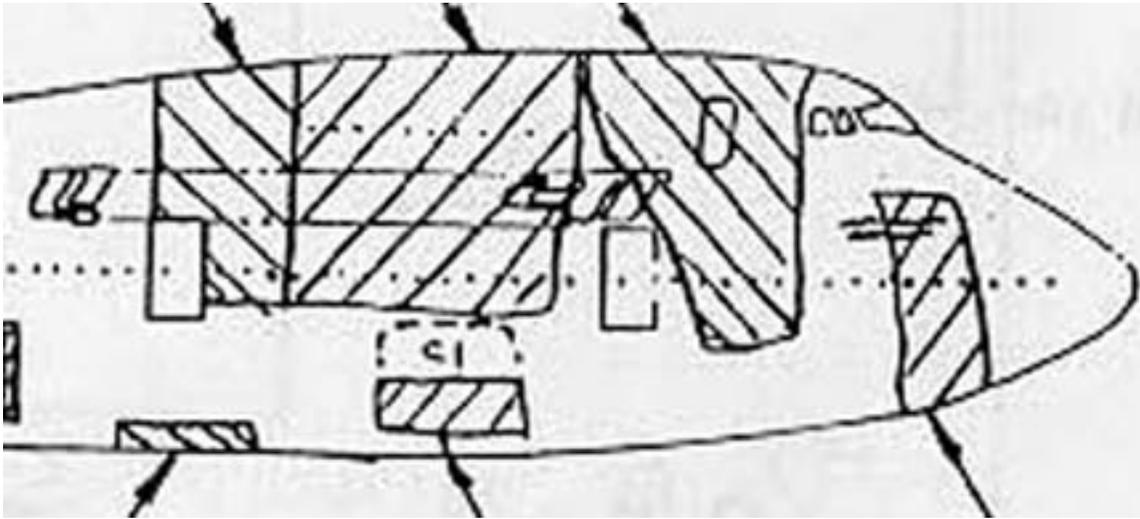
Reconstruction drawing above from the Kirpal Report and the CASB report on Air India Flight 182 showing the longitudinal split of the forward cargo door and the vertical tearing of the skin above the door.

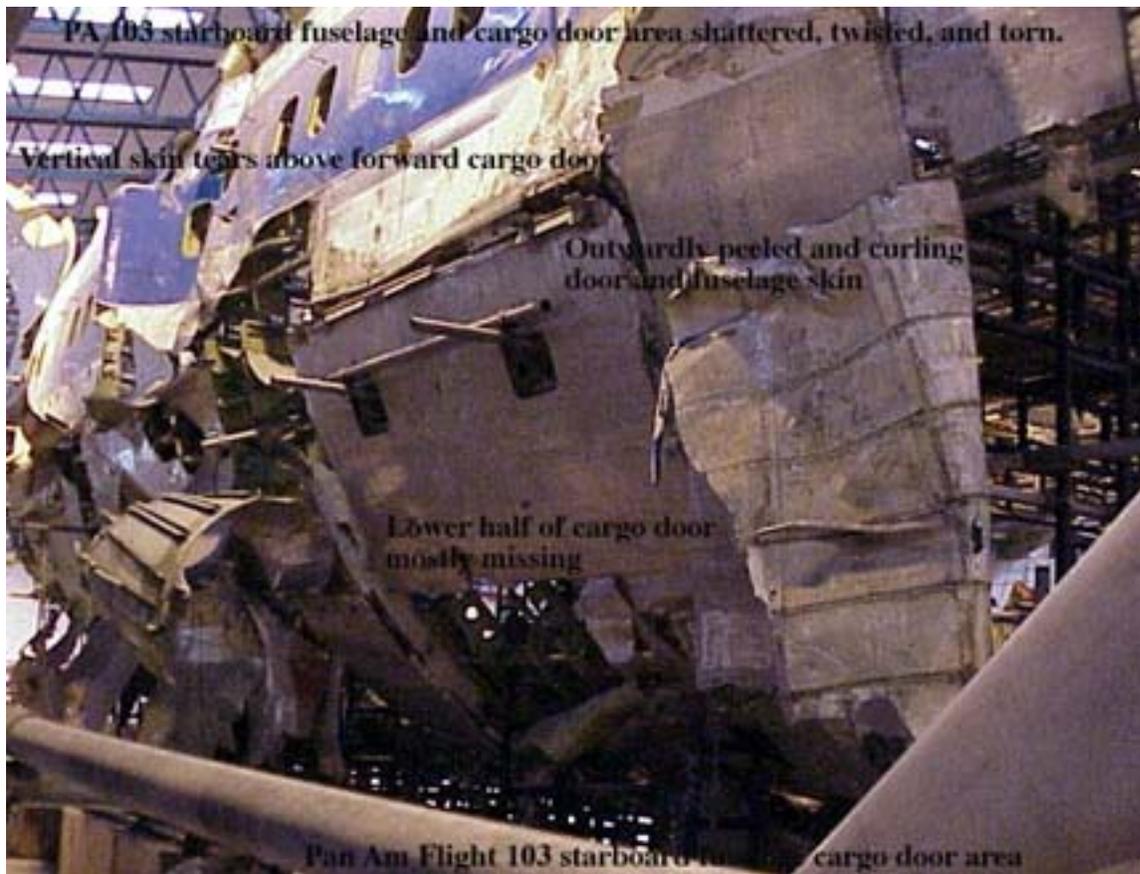
Photograph from AAIB showing Pan Am Flight 103 forward cargo door area revealing the vertical torn skin above door, peeled back and down skin from the aft midspan latch, generally shattered area, and mostly missing lower half of door which includes the manual locking handle and the eight bottom latches.

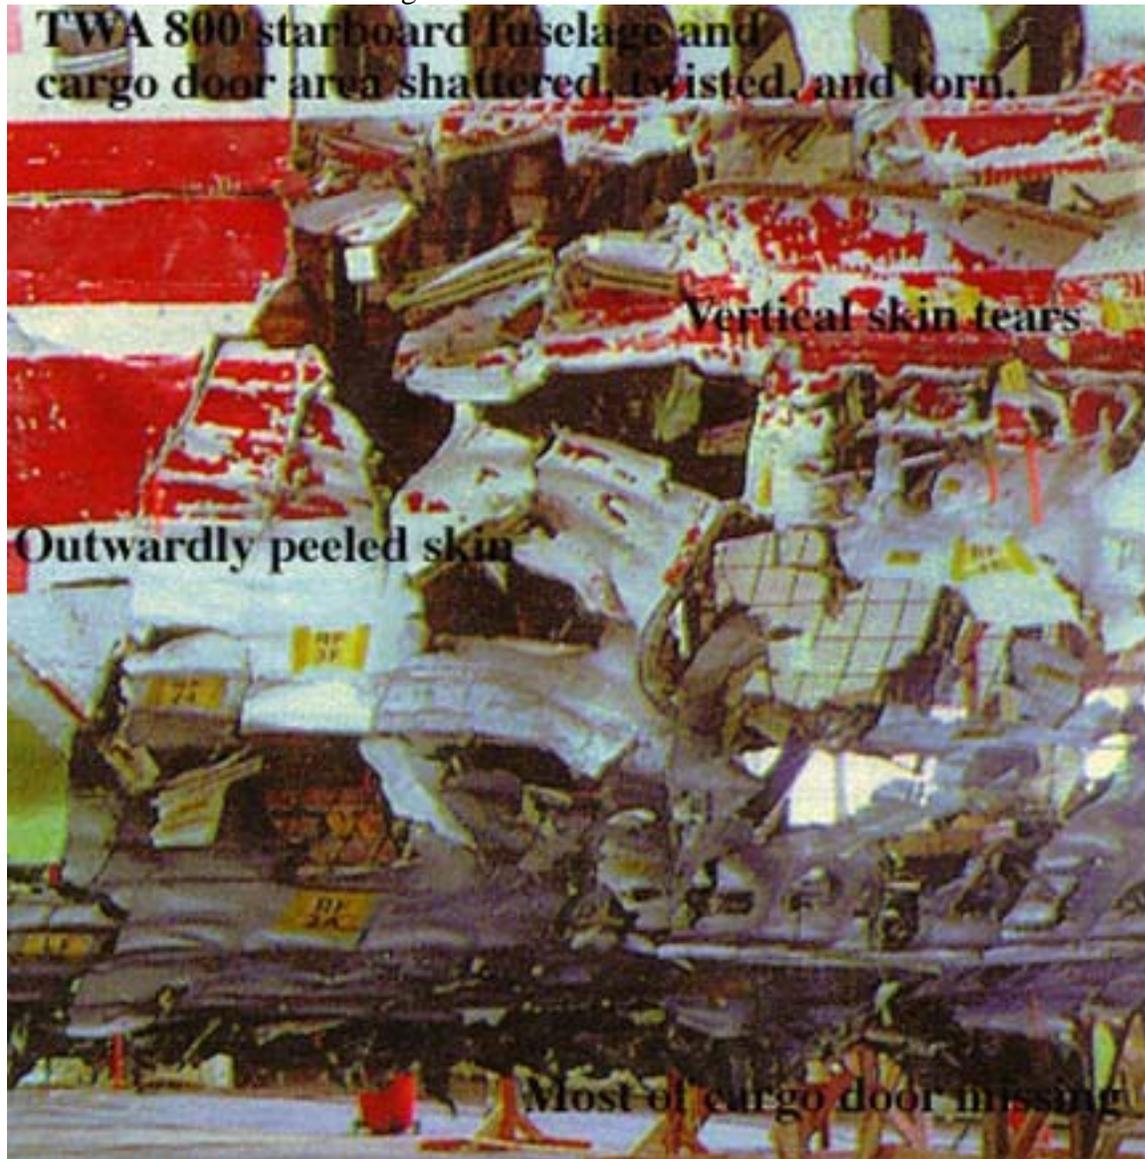
Shattered starboard side around forward cargo door of Trans World Airlines Flight 800 revealing outwardly and petaled shaped skin around aft midspan latch.
