**AIRCRAFT
ACCIDENT
REPORT
Pan Am Flight 103
Part I
Consideration of Reasonable Probable Causes**

**Report on the accident to
Boeing 747-121, N739PA
at Lockerbie, Dumfriesshire, Scotland
on 21 December 1988
by John Barry Smith,
Independent Aircraft Accident Investigator**

Part I: Consideration of Reasonable Probable Causes

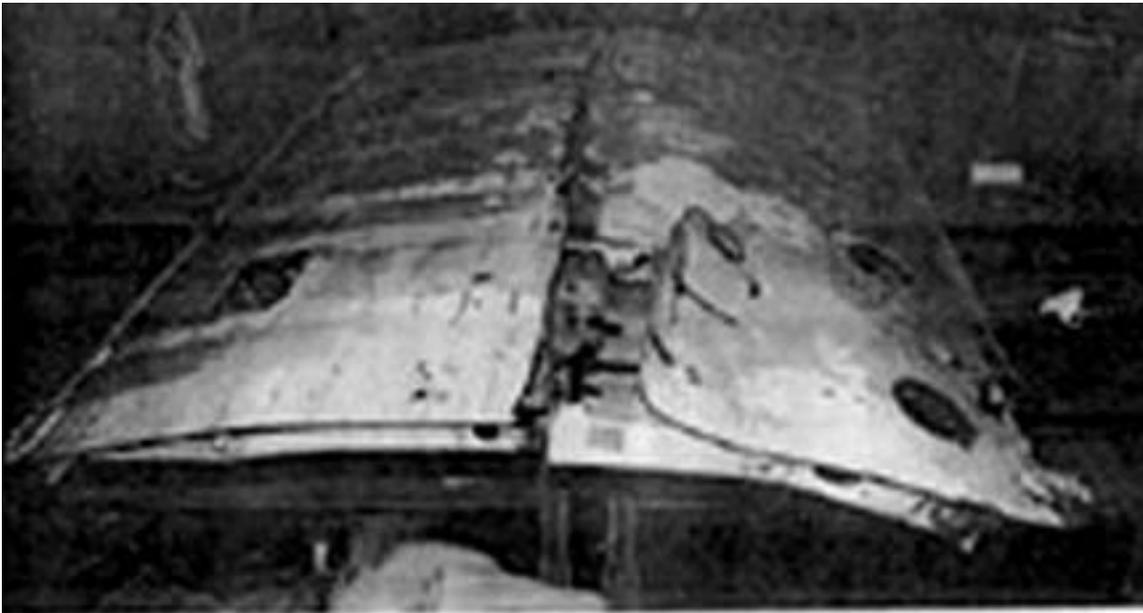
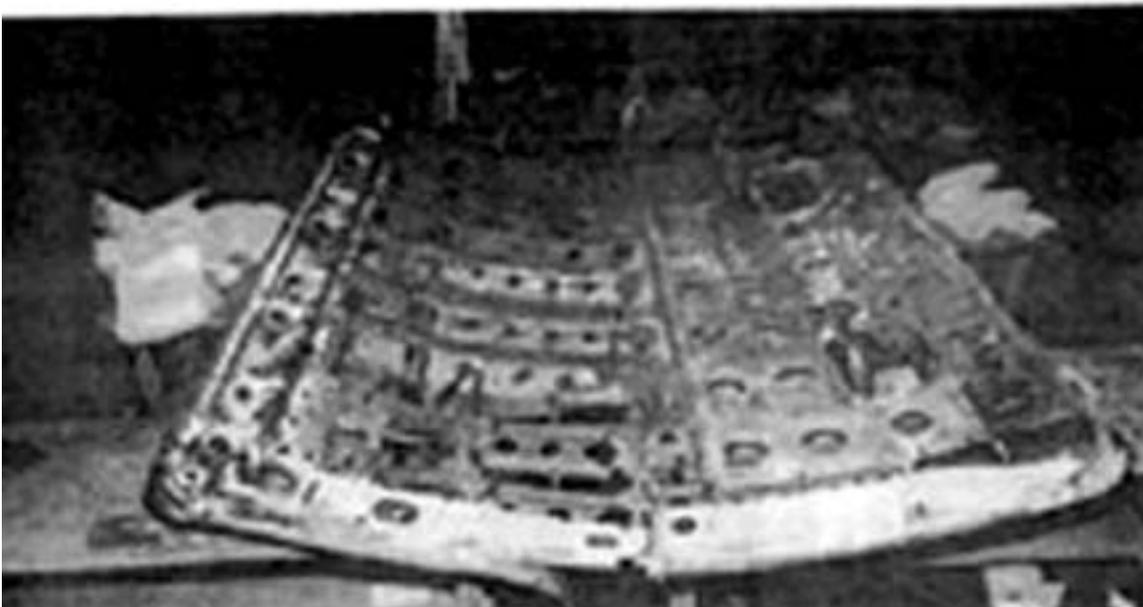
United Airlines Flight 811 forward cargo door showing missing aft pressure relief door and jammed open status of forward pressure relief door according to NTSB AAR 92/02.

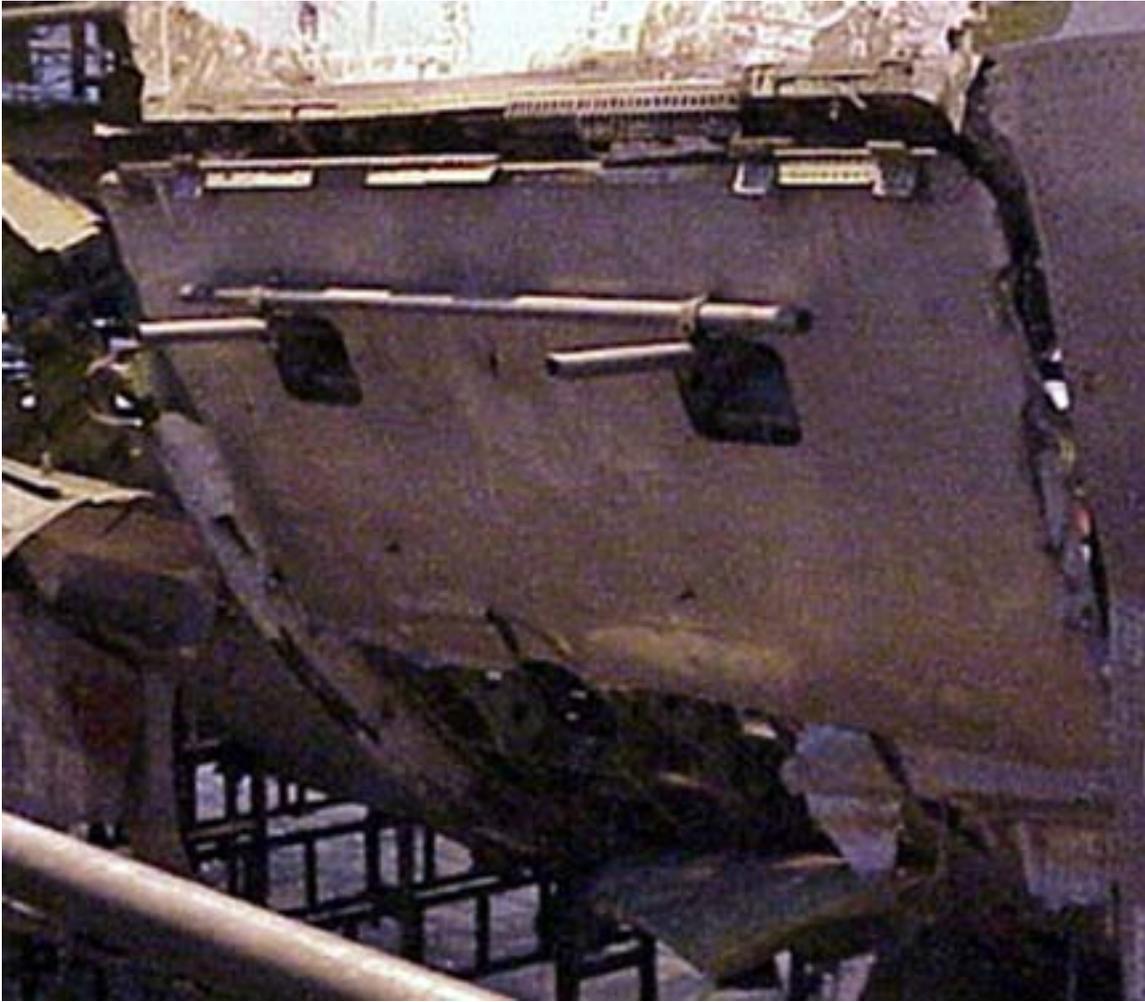
Pan Am Flight 103 Forward cargo door showing missing aft and forward pressure relief doors.

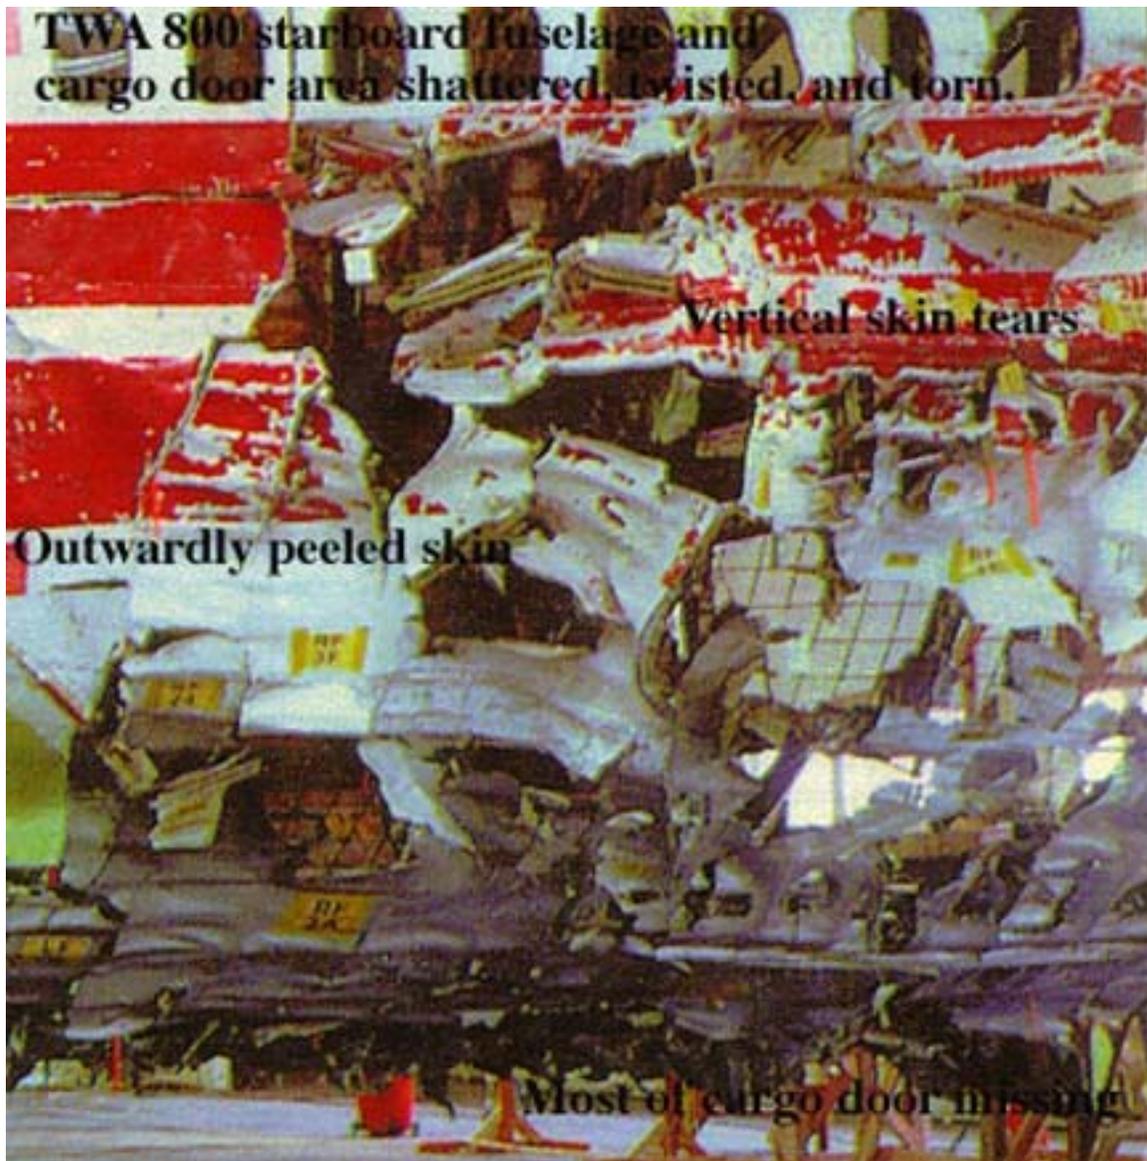
Trans World Airlines Flight 800 Forward cargo door showing missing aft pressure relief door.

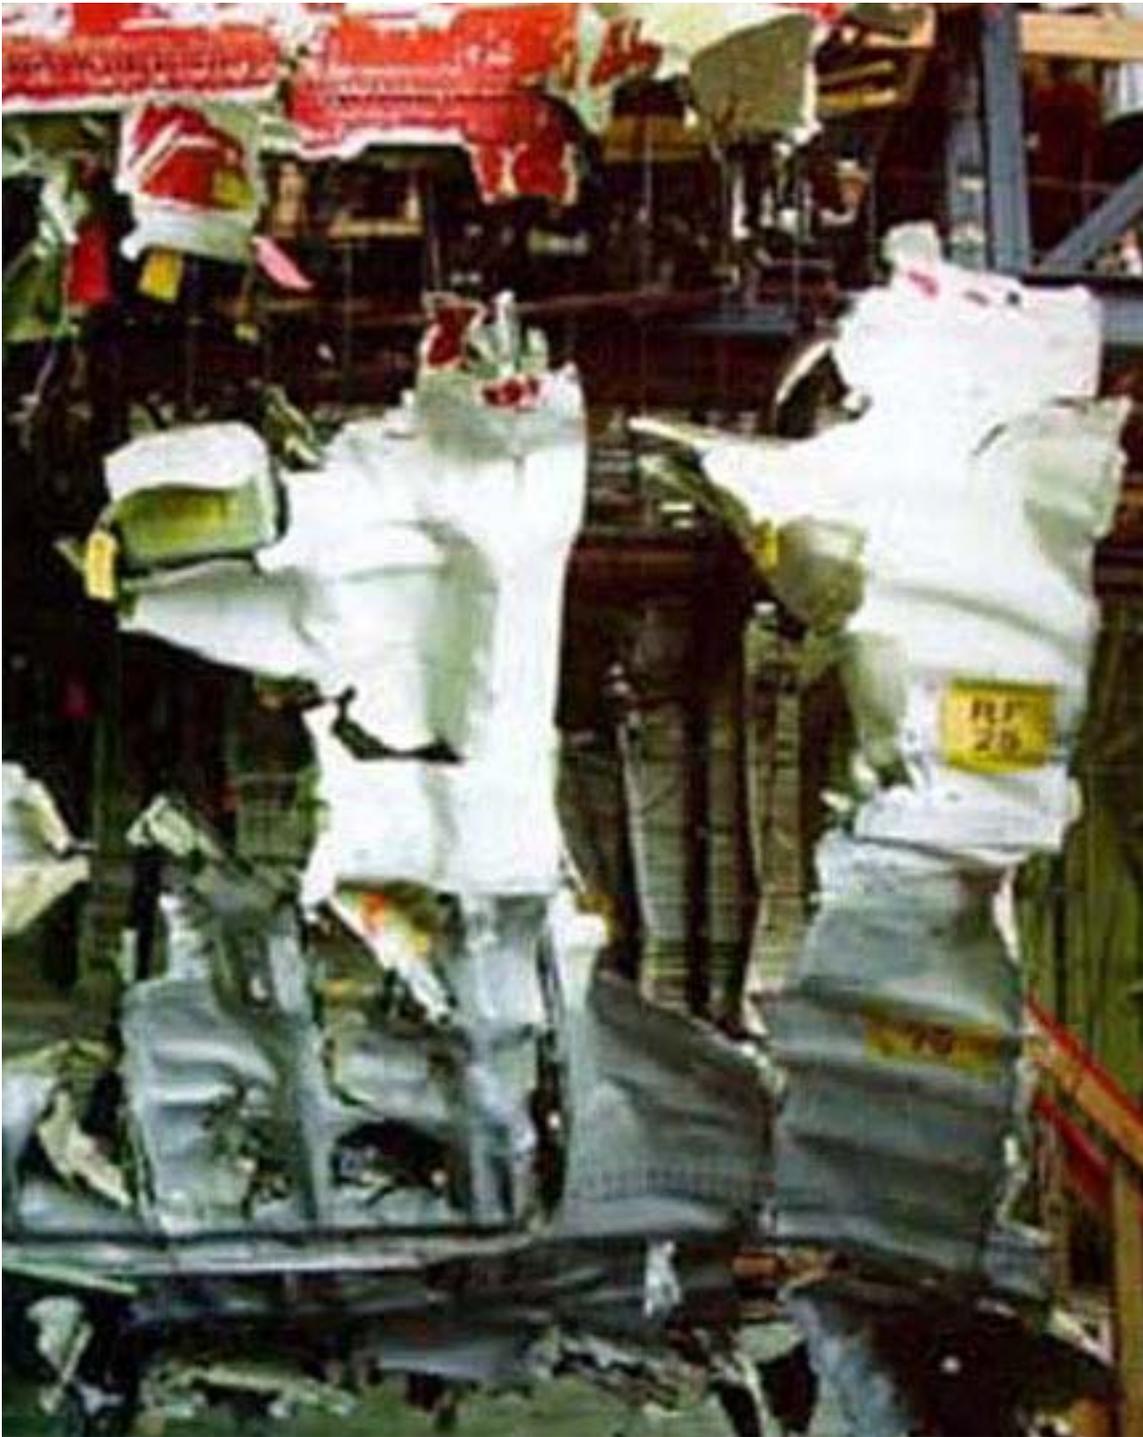
Trans World Airlines Flight 800 Forward cargo door showing separated and replaced forward pressure relief door.

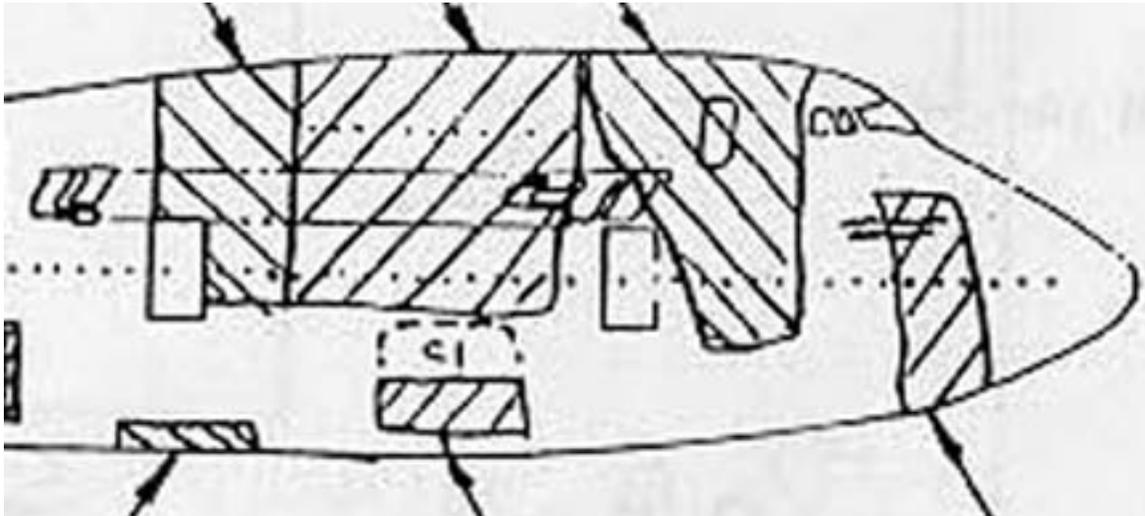
Air India Flight 182 Forward cargo door showing missing top half of door including the aft and forward pressure relief doors.
