**AIRCRAFT
ACCIDENT
REPORT**
Air India Flight 182

**Report on the Accident to Boeing 747-237B VT-EFO, Air India Flight 182,
Off Cork, Ireland on 23 June 1985
by John Barry Smith,
Independent Aircraft Accident Investigator**

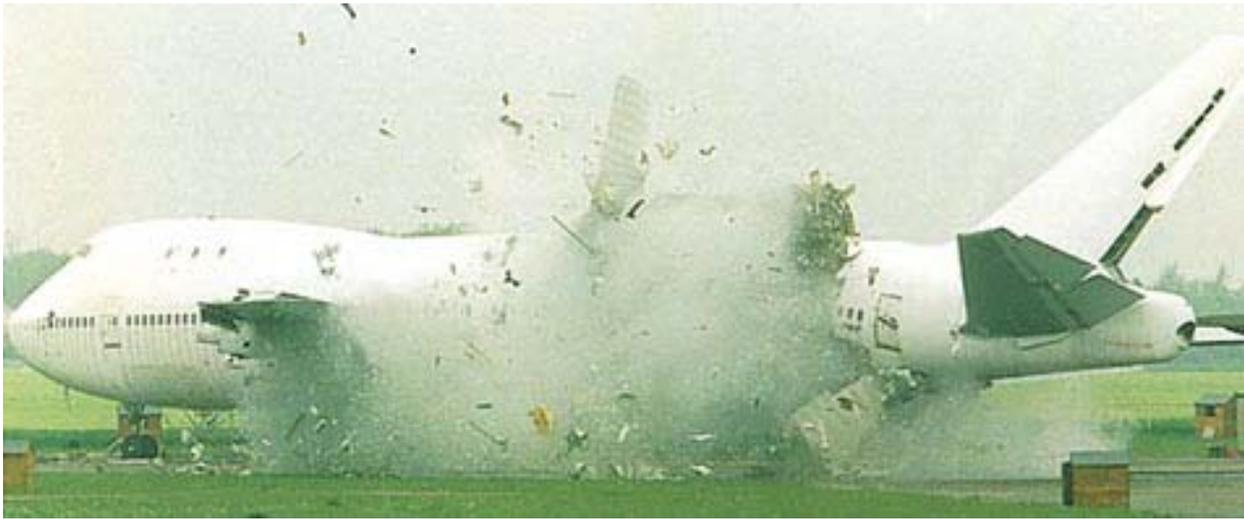
Above is a picture of the staged bombing of a Boeing 747 at Bruntingthorpe in 1997.

The aft section evidence which resulted from the real bomb explosion above does not match the aft section evidence examined for Air India Flight 182 which had undeformed, straight fuselage skin and intact cargo doors. If the above bomb type explosion had occurred in Air India Flight 182, the Canadian and Indian and UK investigative authorities in 1985/1986 would most certainly have detected it because of the obvious hot-gas pitting on pieces of metal, punctures, shrapnel, explosive residue, pitting, cratering, explosive type injuries to passengers sitting in the cabin, timer, fuze, and a bomb explosion sound on the cockpit voice recorder.

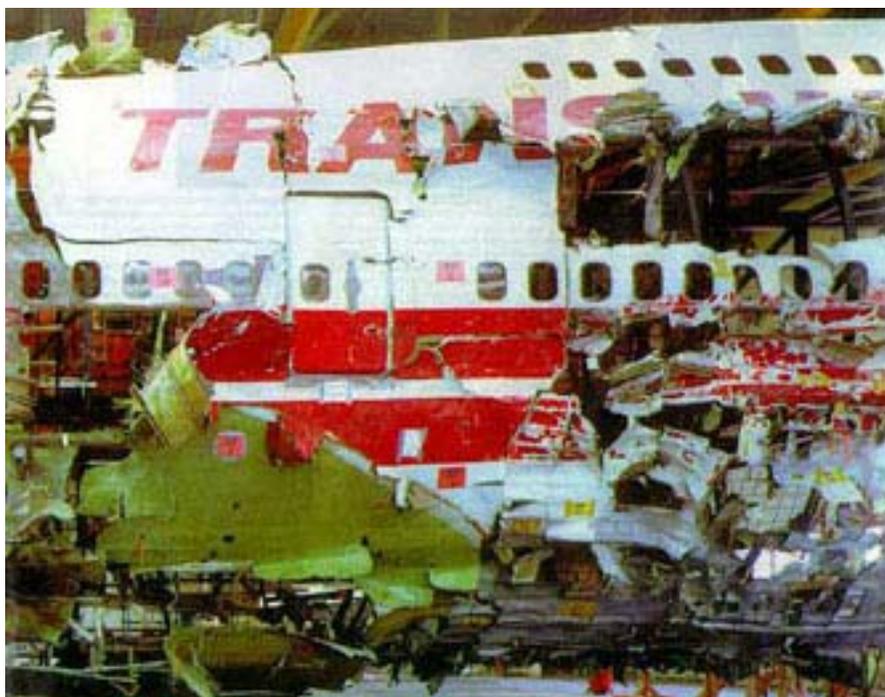
Above is a NTSB photograph of the wreckage reconstruction of Trans World Airlines Flight 800 starboard side over and forward of the wing. Fuselage station 600 is to the right extending to fuselage station 960 to the left in the photograph. A little over half of the forward cargo door is the shattered area in the lower right hand section. An outward opening petal shaped rupture can be seen at the aft midspan latch of the forward cargo door. The mildly damaged right hand, number two passenger door is in the middle left of the photograph.

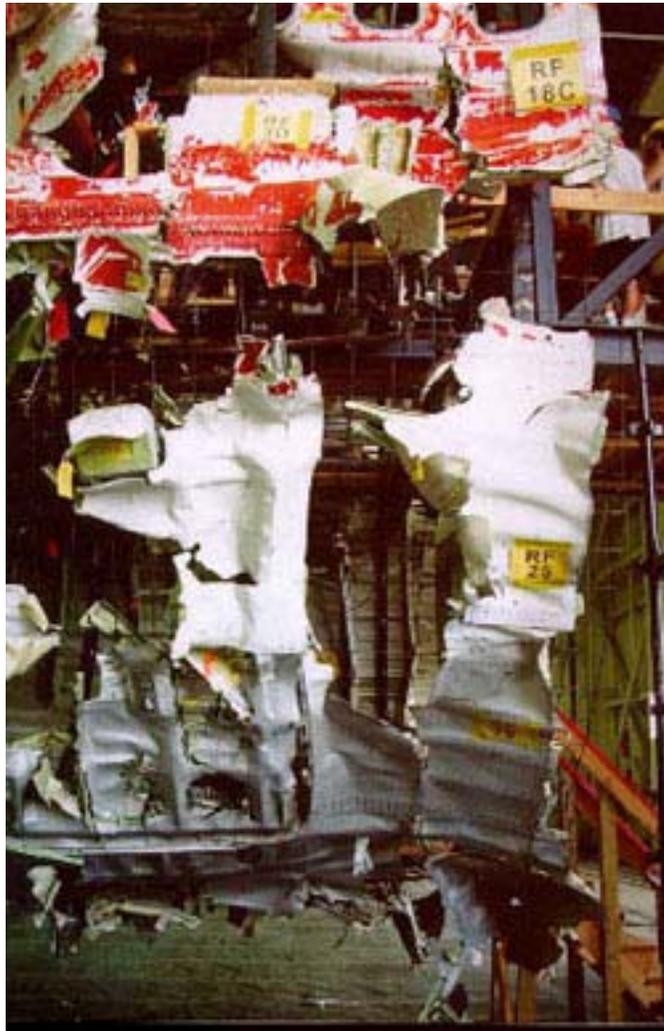
Above is a closeup photograph of about a half of the Trans World Airlines Flight 800 forward cargo door extending from fuselage station 520 on the right to fuselage station 620 to the left in the photograph. The cargo door hinge is in red near the top of the photograph. The outward opening petal shaped oval rupture is located at the forward midspan latch of the forward cargo door.

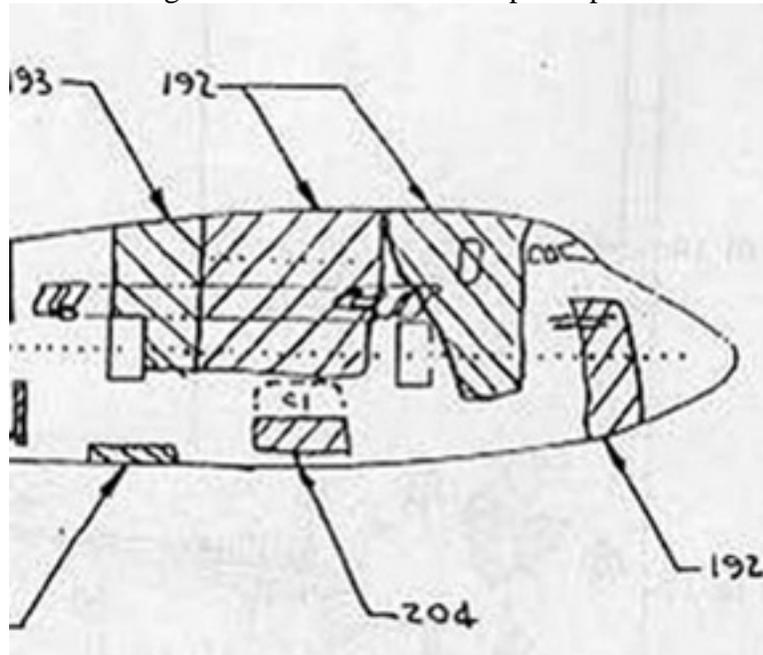
Excerpts of official corroborative drawings and photographs to support all aircraft

had similar shattered skin in and around the forward cargo door. Air India Flight 182 from the Indian Kirpal Report:

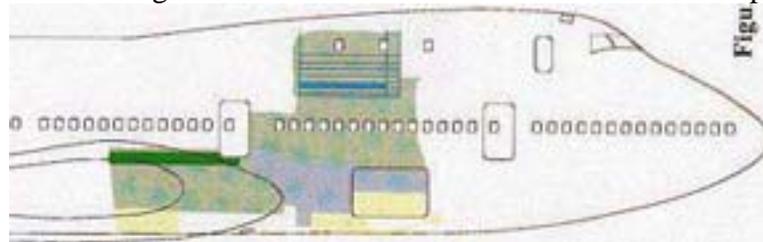
Pan Am Flight 103 below from AAIB Aircraft Accident Report No 2/90

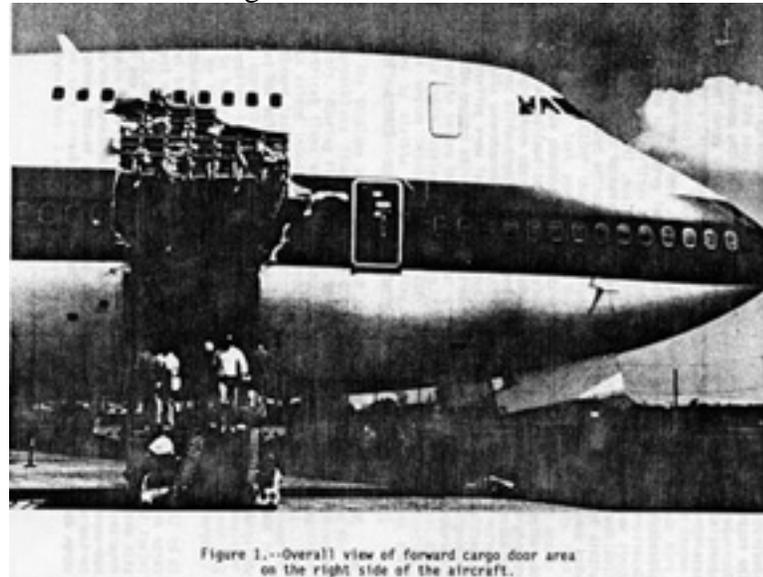
United Airlines Flight 811 below from NTSB AAR 92/02

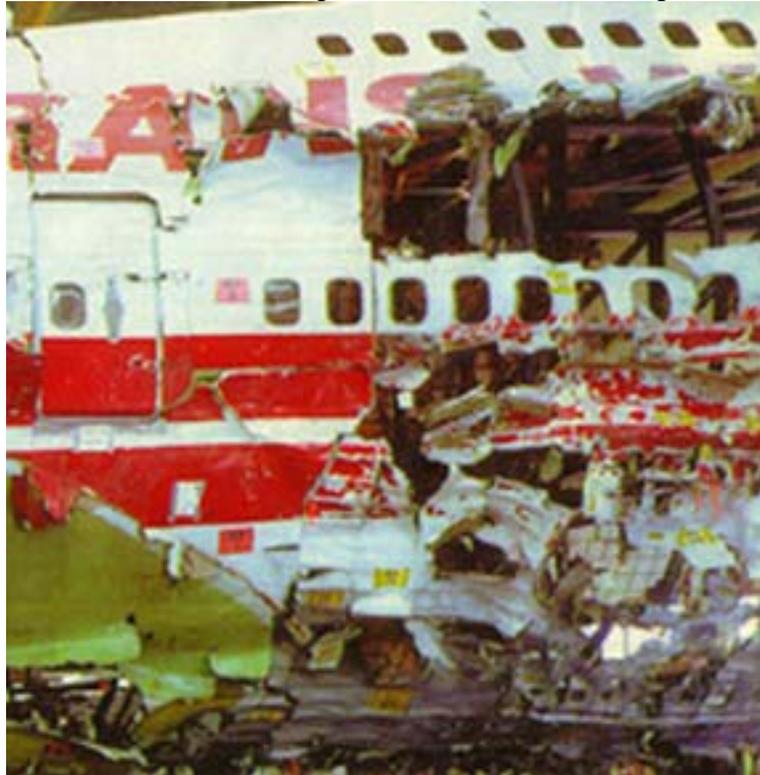
Trans World Airlines Flight 800 below from NTSB public docket and AAR 00/03:

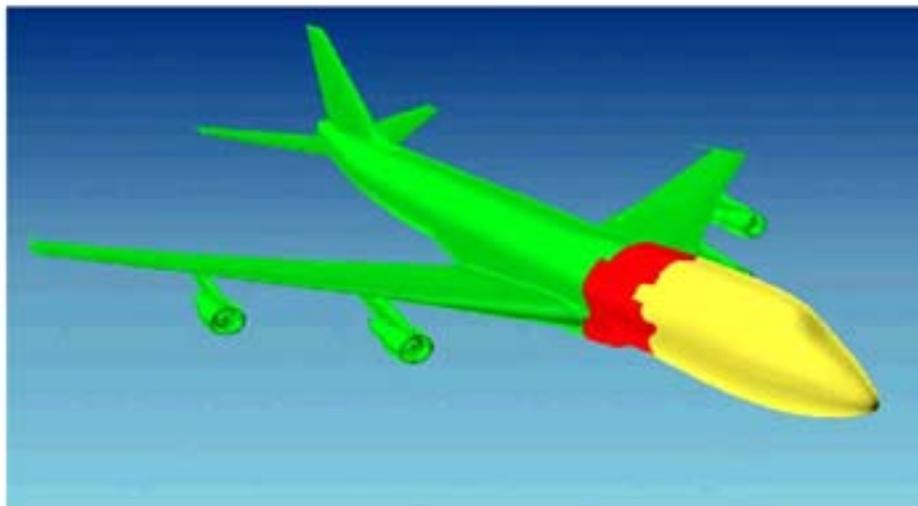
Below illustration shows the red zone of Trans World Airlines Flight 800 which is were all the first debris left the aircraft. The red zone includes the forward cargo door area but the zone is forward of the center fuel tank.

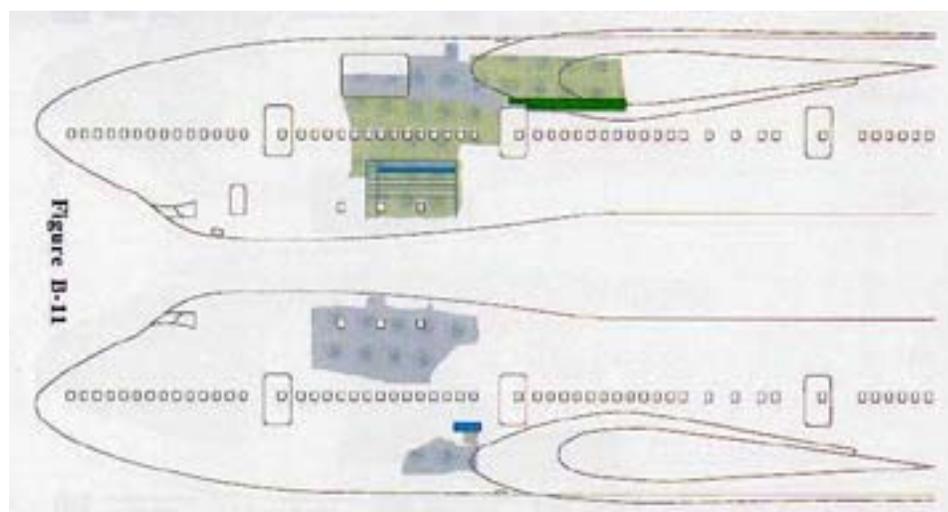
Above drawing from Figure B-11 of the AAIB report shows the large amounts of fuselage skin around the forward cargo door (top drawing) torn away at initial event time while on the port side (bottom drawing) at the same time, only a few pieces are torn off. The dark blue rectangle is the very small 'bomb explosion' shatter zone which is purported to have caused the aircraft to break in two.

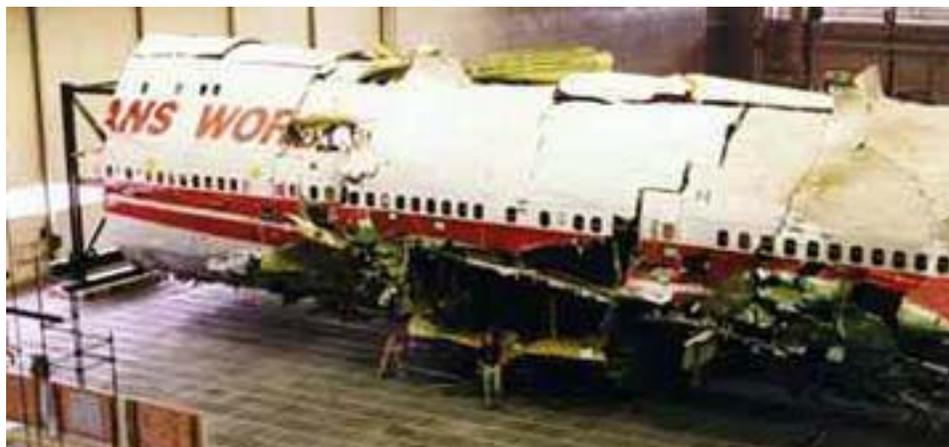
Above photograph shows the smooth port side forward of the wing (nose to left in photograph), while directly opposite the starboard side is shattered and torn. There was no inflight damage to engines Nos. 1 or 2, both on the port side of the aircraft.
