**AIRCRAFT
ACCIDENT
REPORT
Pan Am Flight 103
Part I
Consideration of Reasonable Probable Causes**

**Report on the accident to
Boeing 747-121, N739PA
at Lockerbie, Dumfriesshire, Scotland
on 21 December 1988
by John Barry Smith,
Independent Aircraft Accident Investigator**

Part I: Consideration of Reasonable Probable Causes

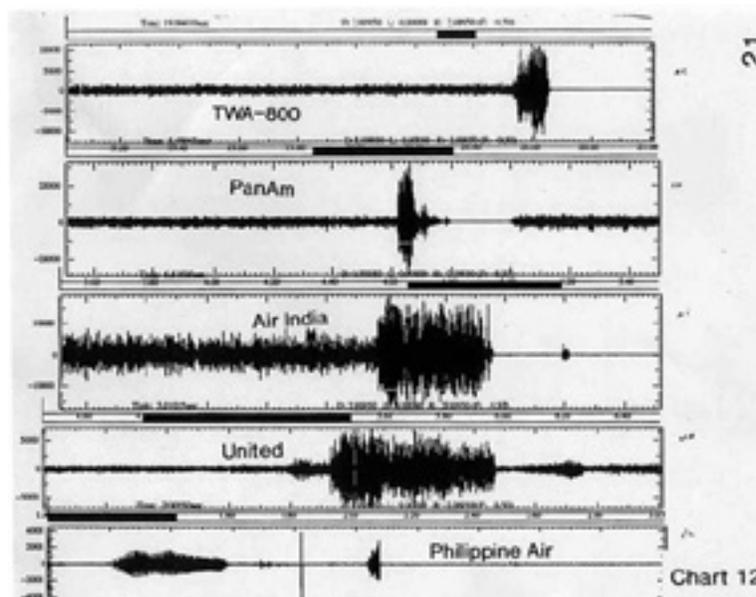
Excerpts of official corroborative statements to support the match that all four flights experienced a sudden, loud audible sound on the cockpit voice recorder at event start time.

Above Chart 12 from TWA 800 Public Docket for TWA 800 and shows CVR data for TWA 800, Pan Am Flight 103, Air India Flight 182, United Airlines Flight 811, and a Philippines Airlines 737.

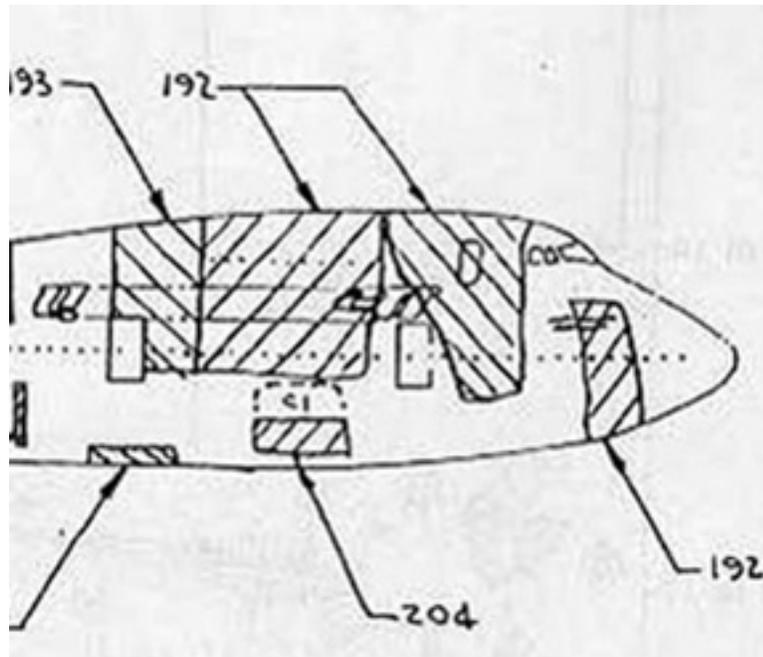
Excerpts of official corroborative drawings and photographs to support all aircraft had similar shattered skin in and around the forward cargo door.
Air India Flight 182 from the Indian Kirpal Report:

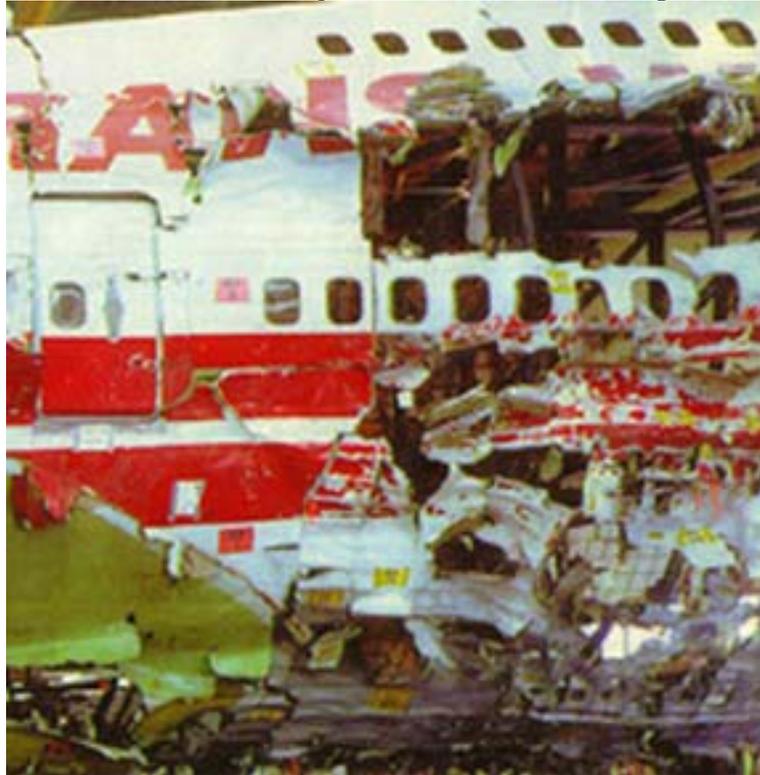
Trans World Airlines Flight 800 photographs show the ruptured, split and shattered forward cargo door.

Trans World Airlines Flight 800 below from NTSB public docket and AAR 00/03:

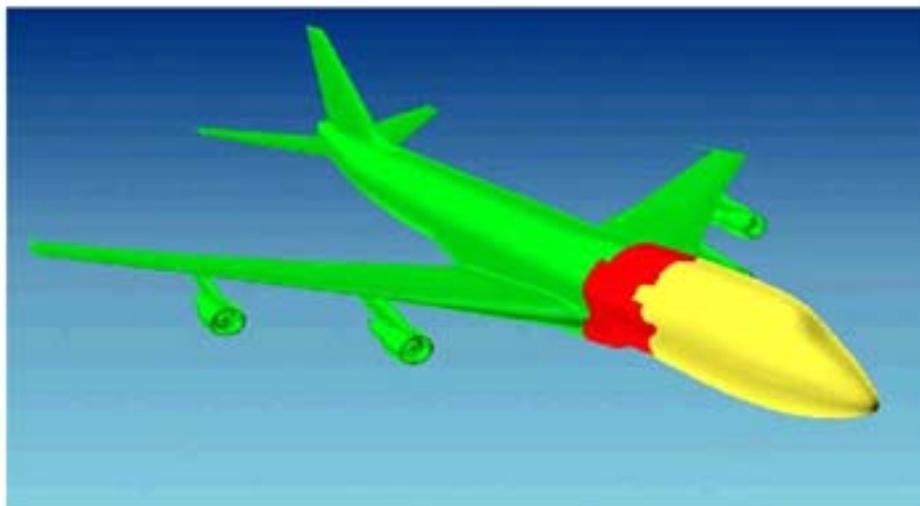
Below illustration shows the red zone of Trans World Airlines Flight 800 which is were all the first debris left the aircraft. The red zone includes the forward cargo door area but the zone is forward of the center fuel tank.

1.12.1 Wreckage Recovered from the Red Zone The red zone was the largest of the three zones and was located farthest west (closest to JFK) in the wreckage distribution. Pieces recovered from the red zone generally included pieces from between about fuselage STA 840 and about fuselage STA 1000 (the aft portion of section 42 see figure 3a for station references); the structure from the aft end of the forward cargo compartment; and pieces from the WCS, including most of the front spar, a large portion of SWB3, and the manufacturing access door from SWB2.

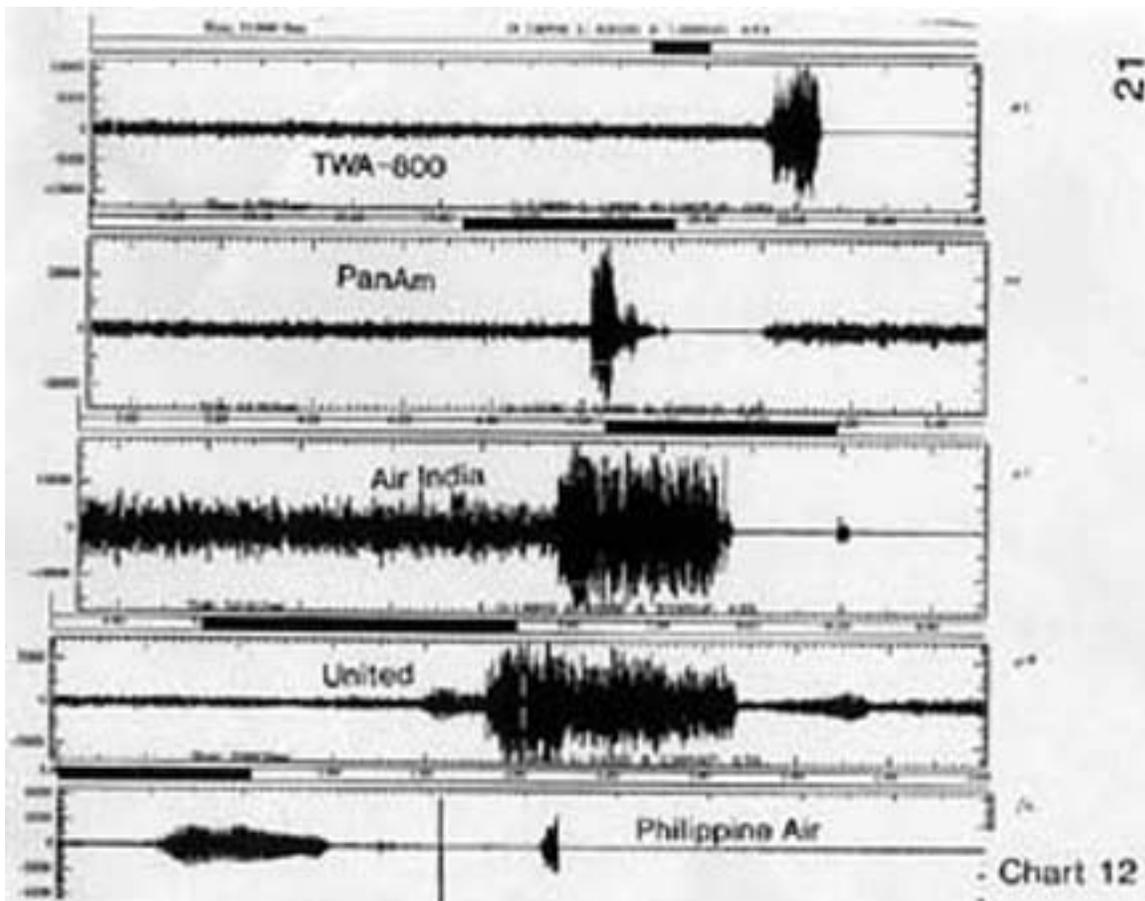
Chart 12 from Public Docket for Trans World Airlines Flight 800 comparing the sudden loud sounds from Trans World Airlines Flight 800, Pan Am Flight 103, Air India Flight 182, United Airlines Flight 811 and a Boeing 737.

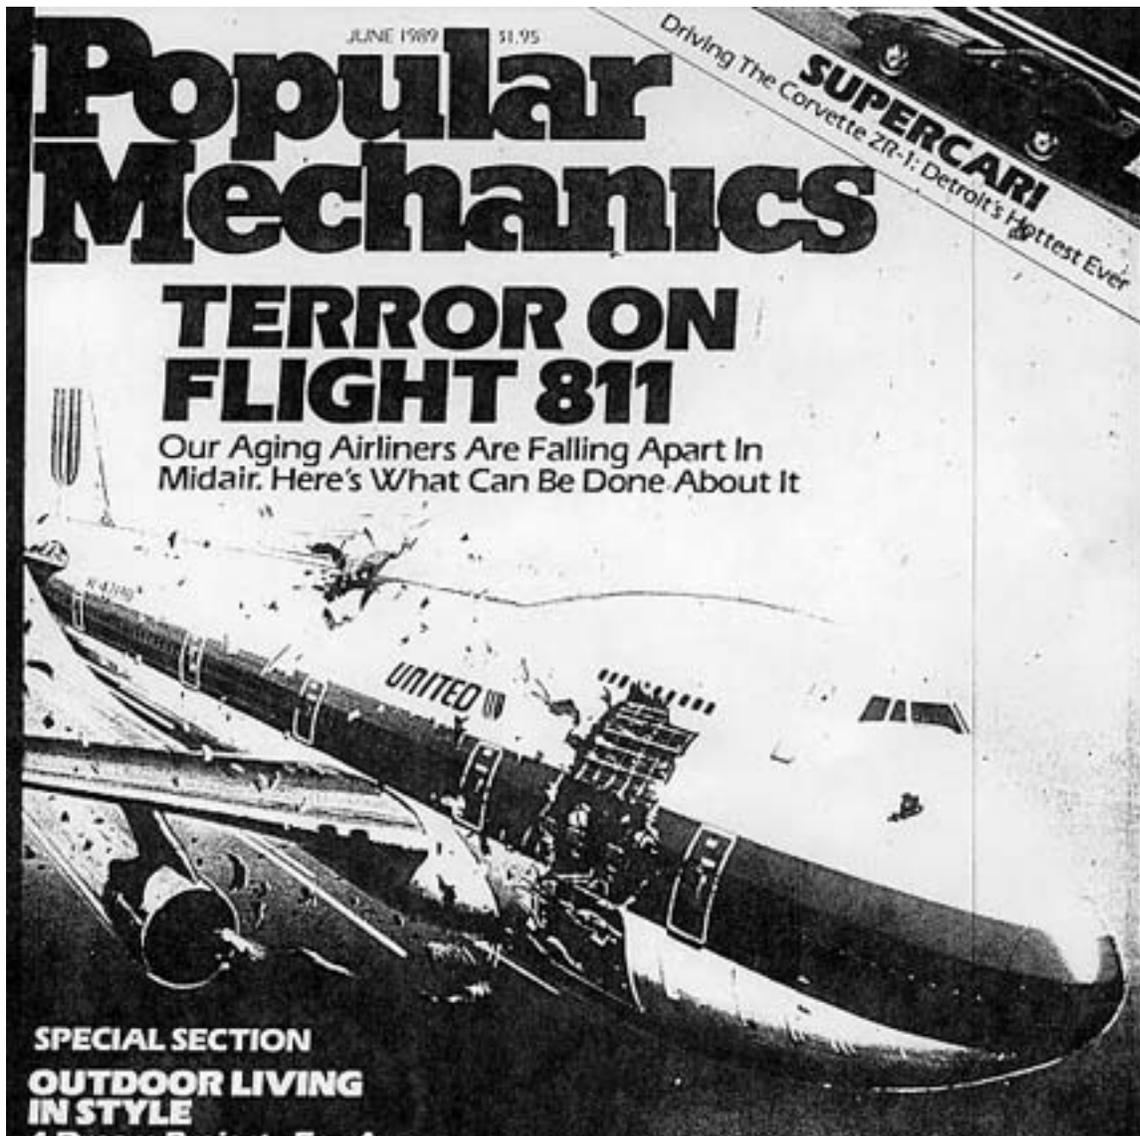
Melodramatic artist's impression on cover of June 1989 Popular Mechanics showing United Airlines Flight 811 as it descends to land after inadvertent opening of forward cargo door in flight.

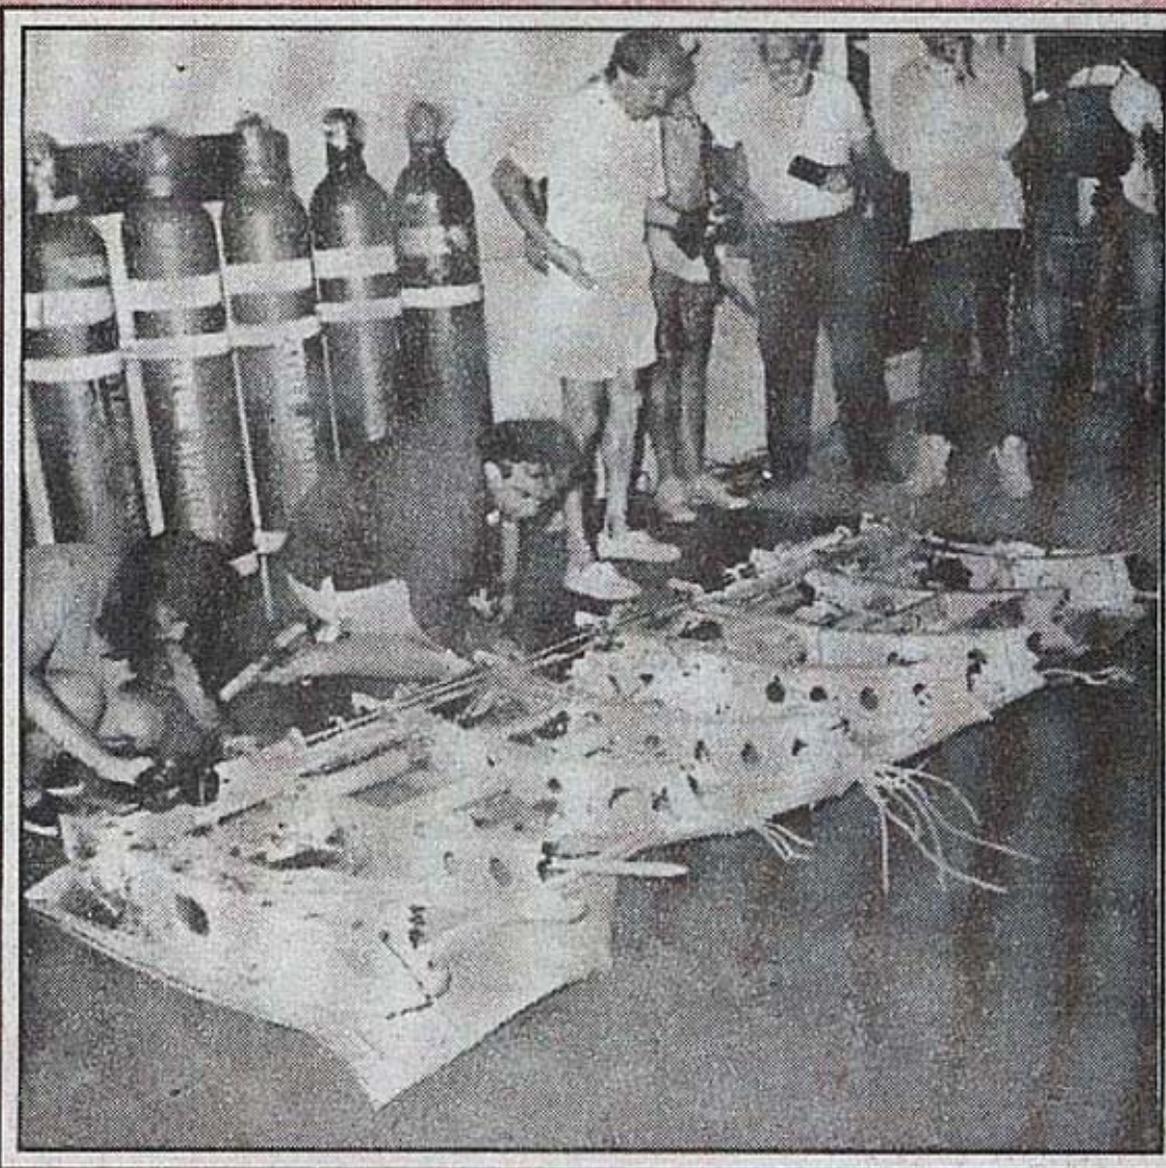
The bottom half of the cargo door from United Flight 811 is examined on board a Navy contract support ship after it was retrieved from a depth of nearly three miles. The crew of the mini-sub Sea Cliff hopes to recover the top half this weekend. See story on Page A3.

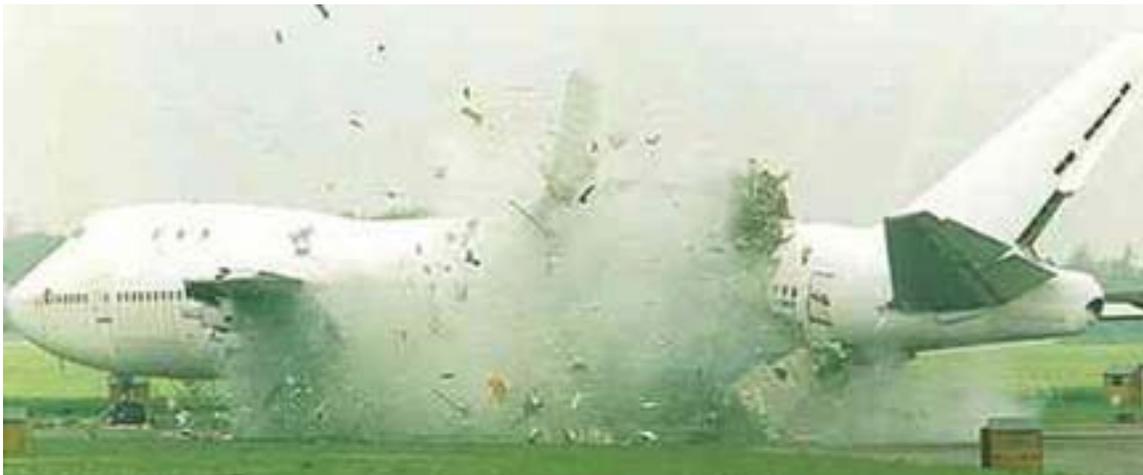
Inflight damage to the airframe of Pan Am Flight 103 does not match airframe damage from a staged bomb explosion event in a Boeing 747 at Bruntingthorpe.

Staged bombing of a Boeing 747 at Bruntingthorpe UK showing the massive damage which occurs when a real bomb goes on in a Boeing 747.

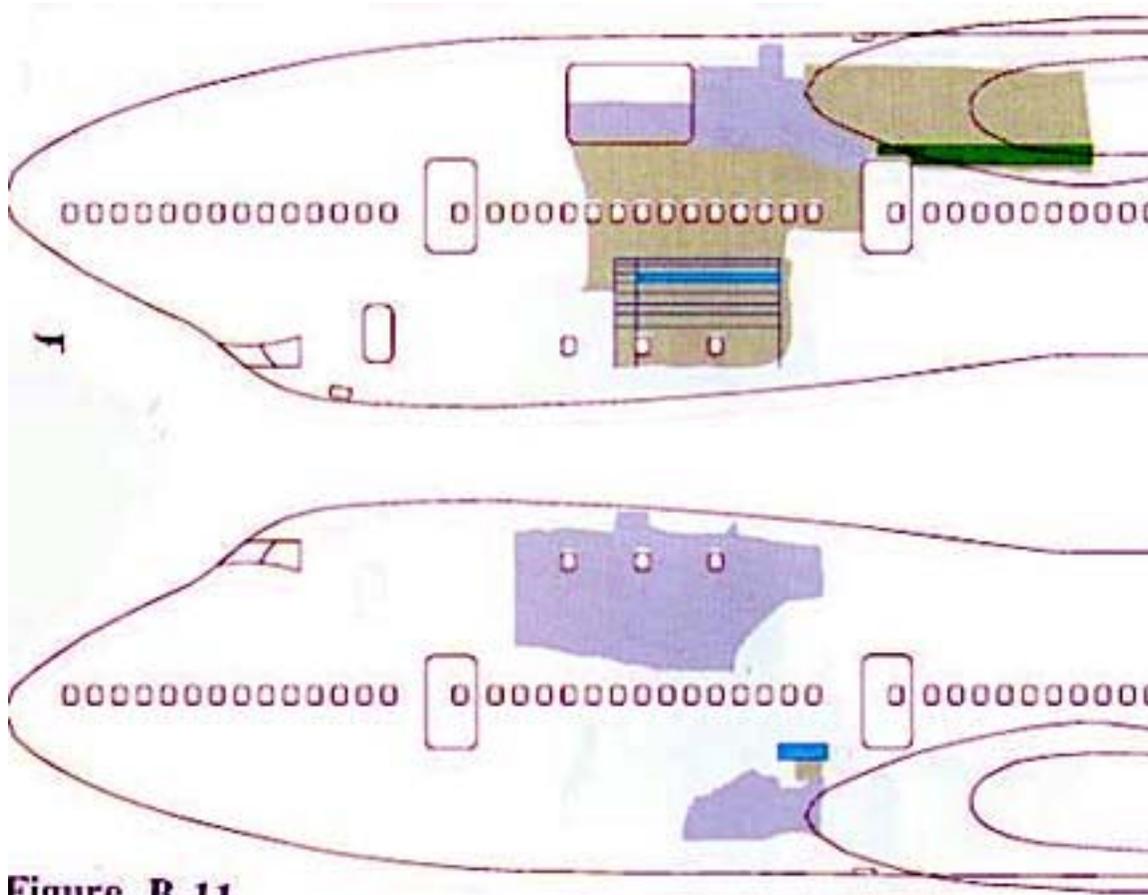
Figure B-11

Figure B11 from AAIB 2/90 for Pan Am Flight 103 showing initial event time fuselage destruction with small 'bomb' hole rectangle on port side and huge rectangular destruction around forward cargo door on starboard side.

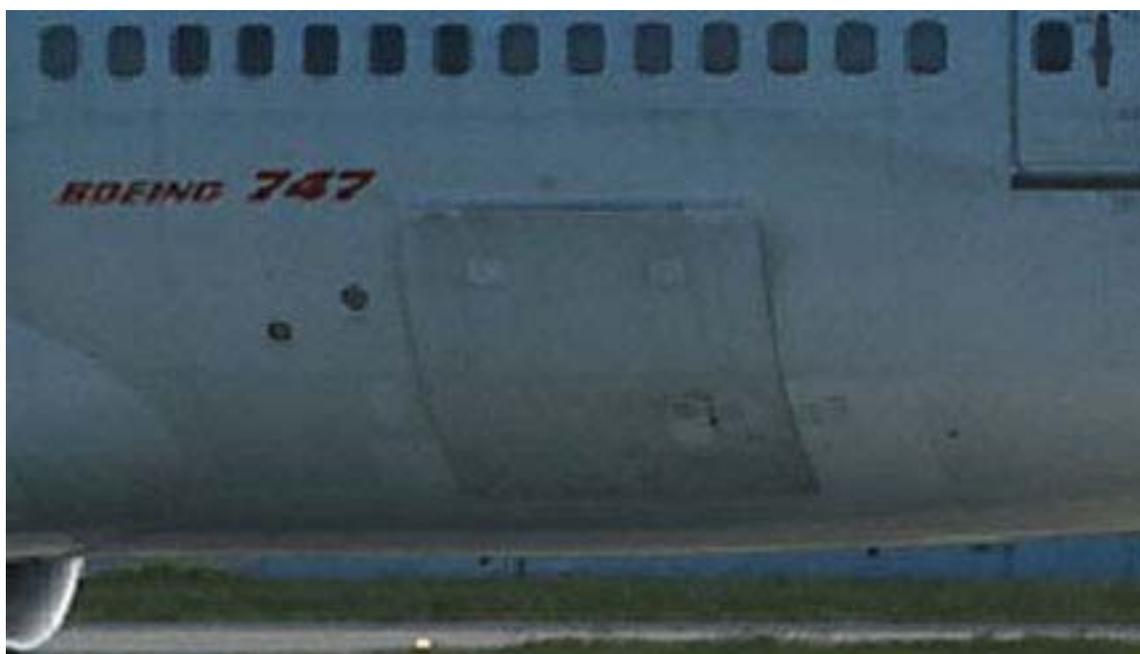
Appendix N: Pressure Relief Doors

Normal Boeing 747 forward cargo door showing aft and forward pressure relief doors near top hinge.
