**AIRCRAFT
ACCIDENT
REPORT**
Air India Flight 182

**Report on the Accident to Boeing 747-237B VT-EFO, Air India Flight 182,
Off Cork, Ireland on 23 June 1985
by John Barry Smith,
Independent Aircraft Accident Investigator**

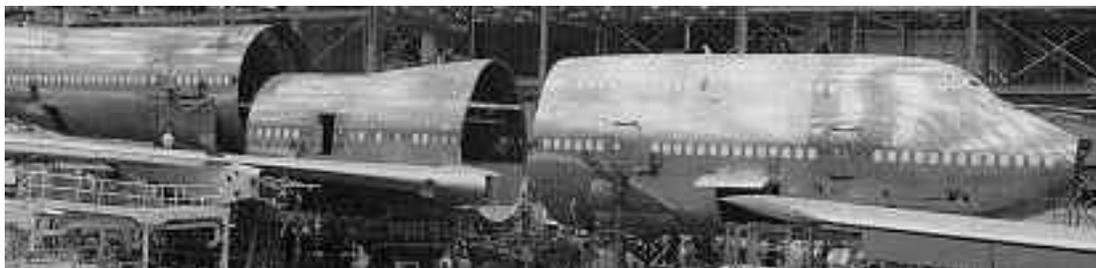
The Garstang Report reports that the breakup location is at the Section 44 and Section 46 joint which is to be expected with an inflight breakup since that is where the sections are mated in construction, but not expected if a powerful bomb were to explode in the aft cargo compartment which would have split and shattered the fuselage in the middle of Section 46 leaving much obvious evidence of the bomb explosion.

Above picture is of a Boeing 747 during construction and shows the sections being mated. Section 41 has already been mated to Section 42. The unjoined joint on the left is the Section 44/Section 46 joint.

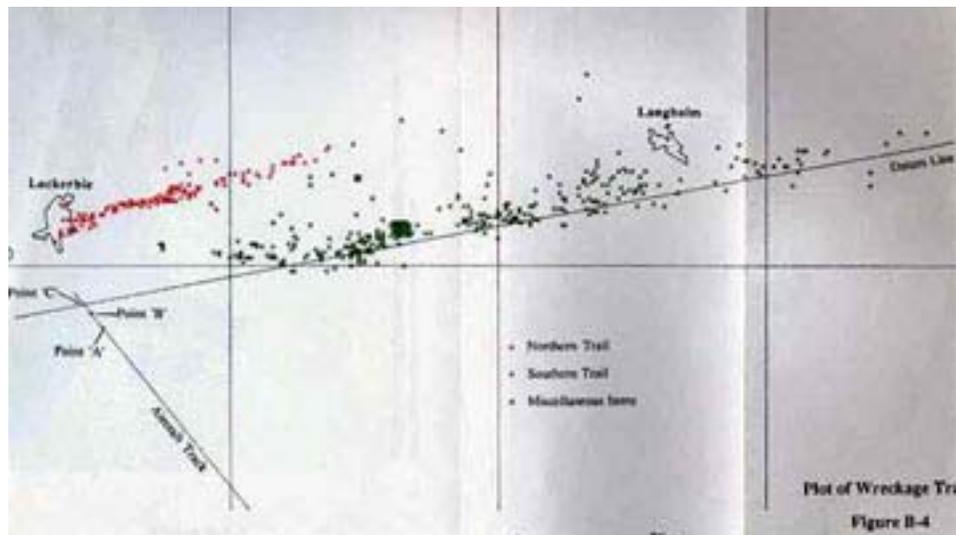
Above drawing shows wreckage trails for Pan Am Flight 103 from the AAIB AAR 2/90

The debris patterns of Air India Flight 182 and Pan Am 103 do match. Both events were carefully examined for the location of the explosion that broke the aircraft apart amidships. Both events have conclusive evidence of an explosion in the forward cargo compartment to explain the breakup. Both events had none of the evidence to support an assertion of an explosion from any source in the aft cargo compartment. The matching debris patterns of both events confirm the conclusions of the British, Indian, and Canadian investigators who stated in their respective aircraft accident reports that the explosion in each aircraft occurred in the forward cargo compartment and did not occur in the aft compartment.

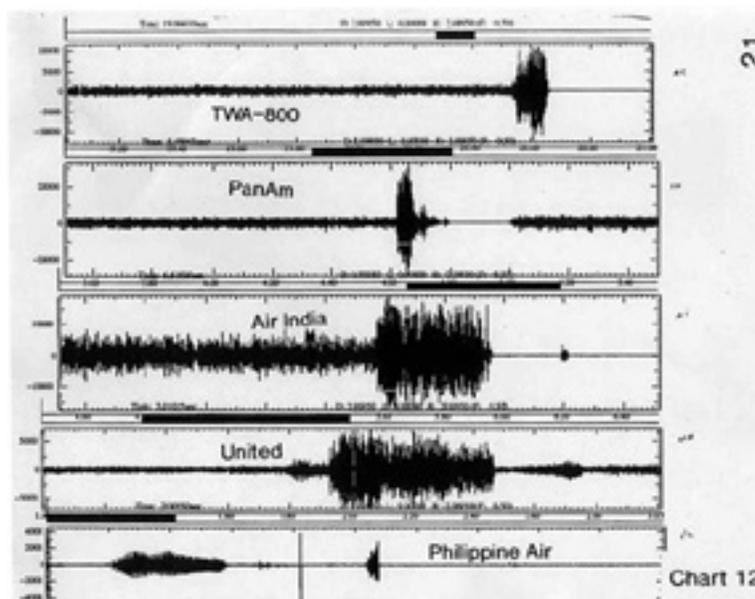
Above Chart 12 from TWA 800 Public Docket for TWA 800 and shows CVR data for TWA 800, Pan Am Flight 103, Air India Flight 182, United Airlines Flight 811, and a Philippines Airlines 737.

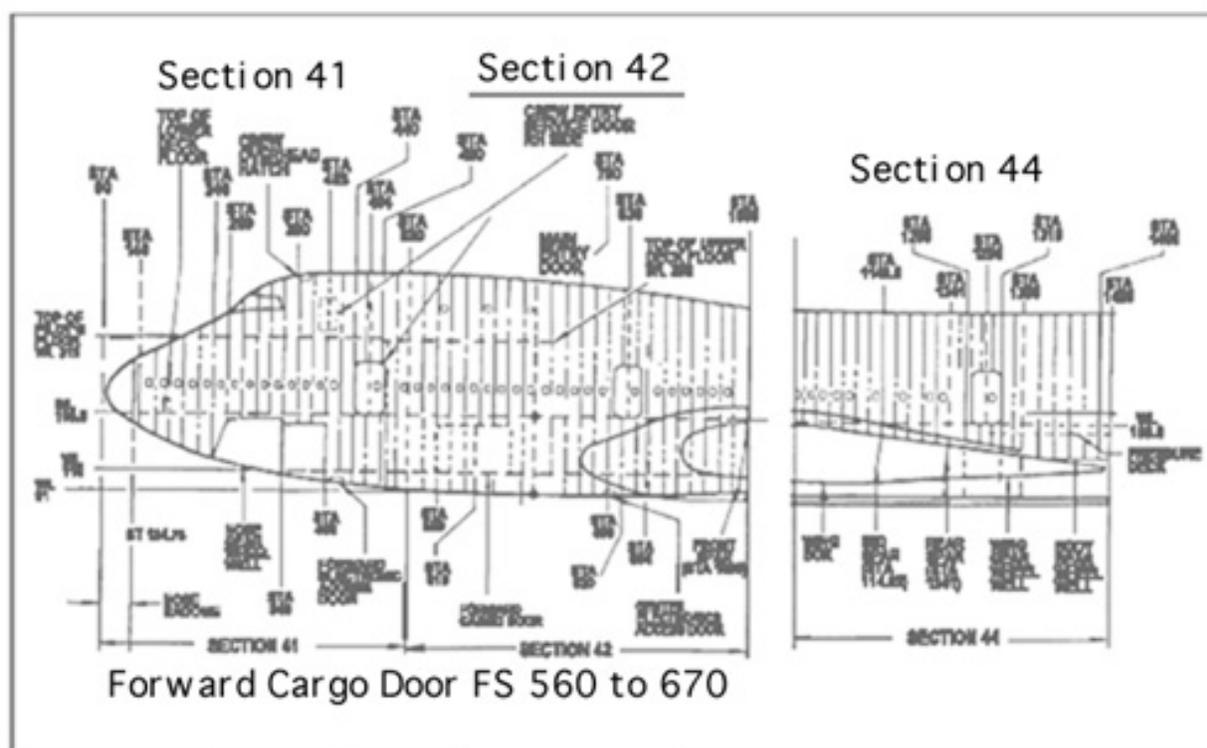
Figure 3a. Locator of fuselage sections 41, 42, and 44.

Above is a drawing from NTSB AAR 00/03 showing fuselage station numbers and sections.

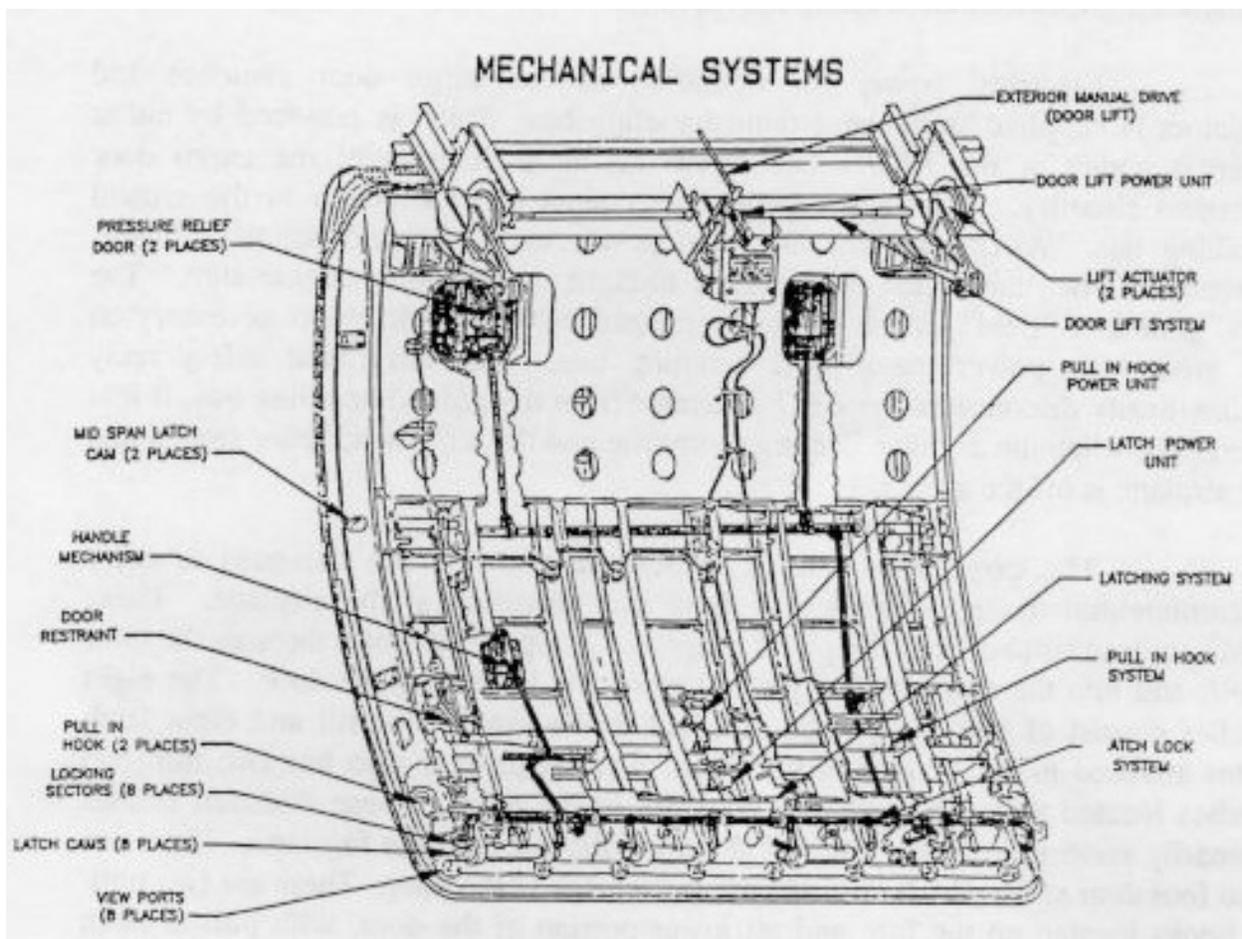
8. Cargo Door Operation for Boeing 747: Drawing of Boeing 747 cargo door from NTSB AAR 92/02

From AAR 92/02 United Airlines Flight 811: 1.6.2 Cargo Door Description and Operation: Normally, the cargo doors are operated electrically by means of a switch located on the exterior of the fuselage, just forward of the door opening. The switch controls the opening and closing and the latching of the door. If at any time the switch is released, the switch will return to a neutral position, power is removed from all actuators, and movement of the actuators ceases.
