AWAKENINGS

TSB WIRE RECOMMENDATIONS

THE MAGAZINE OF THE INTERNATIONAL AVIATION
SAFETY ASSOCIATION

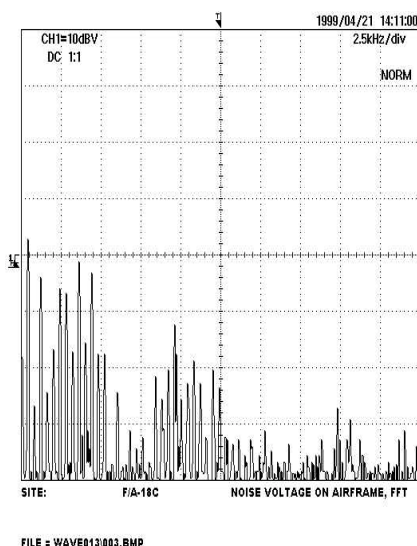
Fig 1: Fourier Transform showing the of the major noise elements on the same airframe. This data was taken with only around 20% of the aircraft loads energized. Most cannot be fired up with "weight on nosewheel". Primarily concentrated below 5 kHz, they are capable of creating all sorts of mischief.

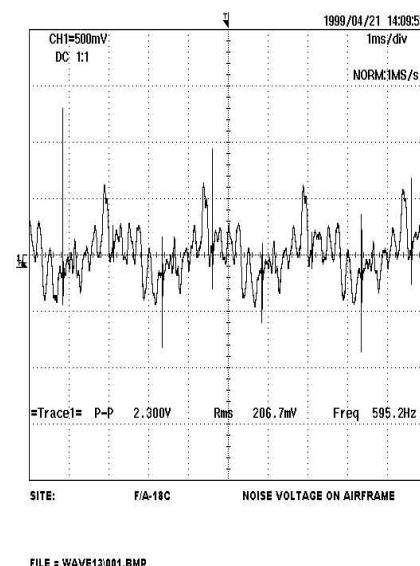
Fig 2: Airframe noise measured on a Digital Sampling Oscilloscope, using shielded test leads, referenced to the hangar static ground. The narrow positive and negative voltage spikes are capable of "forcing" a logic low, with all the possible interesting results.

It is believed that this is one of the most common causes of the "no fault found" gremlin.

A false signal forced in flight may cause a very real system BITE error. But on the ground, after a full system reset, the fault does not appear.
